PATTERNS OF STRUCTURAL FAILURE IN MONTEREY PINE

by Roger J. Edberg, Alison M. Berry and Laurence R. Costello

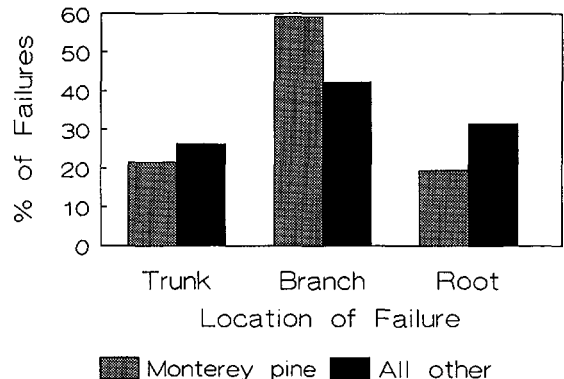
Characteristics of failure - branch. Monterey pine failures (Golden Gate Park and other combined) occurred most frequently at the branch (59%; Figure 2). Branch failures also form the largest category for all other species ("all other"). However, the frequency of branch failure for Monterey pine is significantly greater than for other species (chi-squared, $P=.00$). The sample population was greatly influenced by the predominance of reports from Golden Gate Park trees. Still, the branch failure rate for Monterey pine trees reported from other areas outside the park was significantly higher than that for all other trees in the database grouped together (51% vs 42%, chi-squared, $P=.03$) (Table 1).

Figure 2. Type of failure by location on the tree (trunk, branch, or root). Comparison of Monterey pine and all other trees in the database.

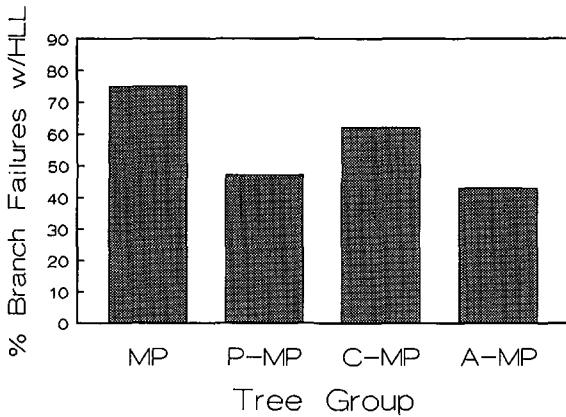
Heavy lateral limbs (HLL) were associated with 75% of all Monterey pine branch failures (MP, in Figure 4). This is nearly double the rate of association of heavy lateral limbs with branch failures for all other species as a group, excluding Monterey pine (43%, A-MP). Other pine species (P-MP) and other conifers in general as a group (C-MP) also

had lower rates of association (47% and 61% respectively). The high association of heavy lateral limbs with Monterey pine branch failure was consistent for failure reports from Golden Gate Park, and from other locations (Table 1). Surprisingly, the average branch diameter for HLL-associated failures was only 12". Long branches, branches with a heavy foliage load, and branches with a heavy cone load may have been included in this category for Monterey pine.

Figure 4. Heavy lateral limbs (HLL) as a structural defect associated with failure. Comparison of Monterey pine (MP) with other pines (P-MP), all conifers except Monterey pine (C-MP), and all other trees in the database (A-MP).
