# PATTERNS OF STRUCTURAL FAILURE IN MONTEREY PINE

by Roger J. Edberg, Alison M. Berry and Laurence R. Costello

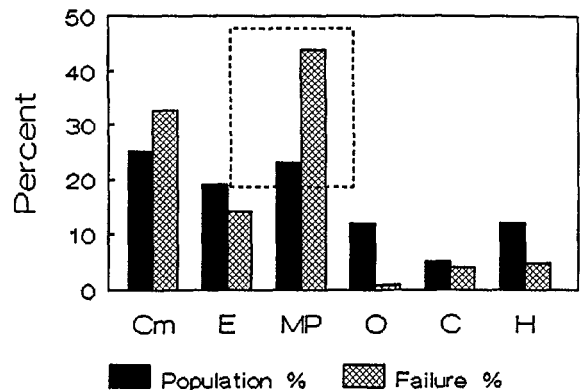
Monterey pines made up 23% of the Golden Gate Park tree population (1980 survey), yet 44% of all reported failures from Golden Gate Park were Monterey pine, substantially higher than the percentage in the park population (Fig. 1). Monterey cypress (*Cupressus macrocarpa*) failed at a rate somewhat higher than its percentage in the park population, while eucalyptus and oak species were reported to fail at a rate approximately equal to, or below their percentage in the population. When additional categories were created, i.e. "other conifers" (all conifers excluding

**Figure 1. Comparison of tree failure frequency and population composition in Golden Gate Park, San Francisco, CA (CM = *Cupressus macrocarpa*, E = Eucalyptus species, MP = Monterey pine, O = oak species, C = conifers, H = other hardwoods).**

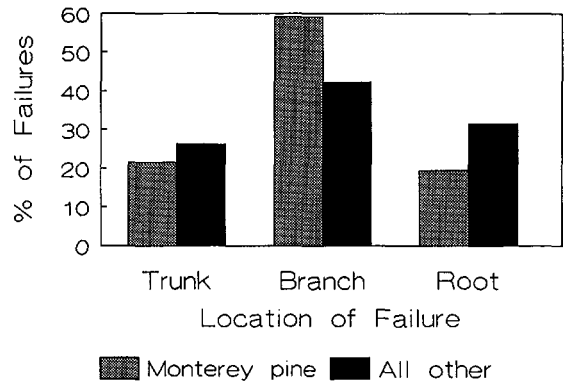
**Characteristics of failure - branch.** Monterey pine failures (Golden Gate Park and other combined) occurred most frequently at the branch (59%; Figure 2). Branch failures also form the largest category for all other species ("all other"). However, the frequency of branch failure for Monterey pine is significantly greater than for other species (chi-squared,  $P=.00$ ). The sample population was greatly influenced by the predominance of reports from Golden Gate Park trees. Still, the branch failure rate for Monterey pine trees reported from other areas outside the park was significantly higher than that for all other trees in the database grouped together (51% vs 42%, chi-squared,  $P=.03$ ) (Table 1).

**Figure 2. Type of failure by location on the tree (trunk, branch, or root). Comparison of Monterey pine and all other trees in the database.**

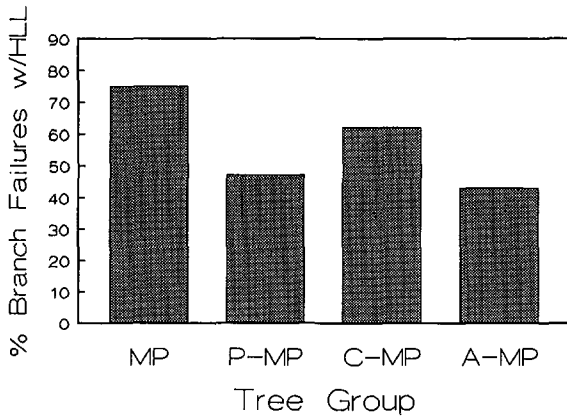
Heavy lateral limbs (HLL) were associated with 75% of all Monterey pine branch failures (MP, in Figure 4). This is nearly double the rate of association of heavy lateral limbs with branch failures for all other species as a group, excluding Monterey pine (43%, A-MP). Other pine species (P-MP) and other conifers in general as a group (C-MP) also

had lower rates of association (47% and 61% respectively). The high association of heavy lateral limbs with Monterey pine branch failure was consistent for failure reports from Golden Gate Park, and from other locations (Table 1). Surprisingly, the average branch diameter for HLL-associated failures was only 12". Long branches, branches with a heavy foliage load, and branches with a heavy cone load may have been included in this category for Monterey pine.

**Figure 4. Heavy lateral limbs (HLL) as a structural defect associated with failure. Comparison of Monterey pine (MP) with other pines (P-MP), all conifers except Monterey pine (C-MP), and all other trees in the database (A-MP).**

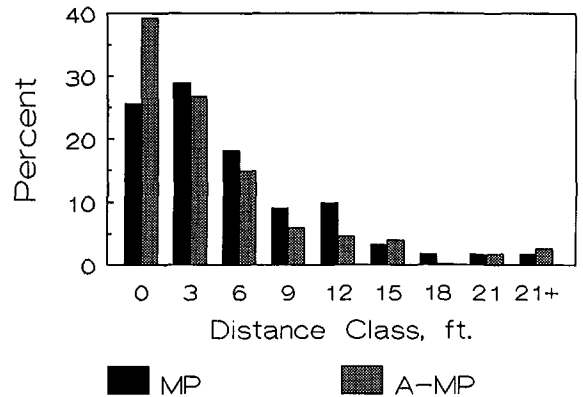
The location of branch failure ranged from the point of attachment with the main trunk to 25 feet out on the branch (Figure 5). Failure occurred flush with the trunk in 26% of all Monterey pine (MP) branch failure reports, while 74% occurred away from the point of attachment. This pattern suggests that most Monterey pine branch failures are not the result of a weak attachment but rather arise from some problem with wood strength or load distribution. Branch failures for all other species (A-MP) in the database grouped together occurred at the attachment in 39% of the reports and out on the branch 61% of the time. A cross-tabulation of branch failures at the attachment or not between Monterey pine and all other species as a group results in a chi-squared probability of .05.

**Figure 5. Branch failures: Distance of break site from point of attachment to trunk (attachment=0 ft., 1-3 ft. class = 3, 4-6 ft class = 6, etc.). Frequency of branch failures per distance class for Monterey pine (MP) and all other species combined (A-MP).**

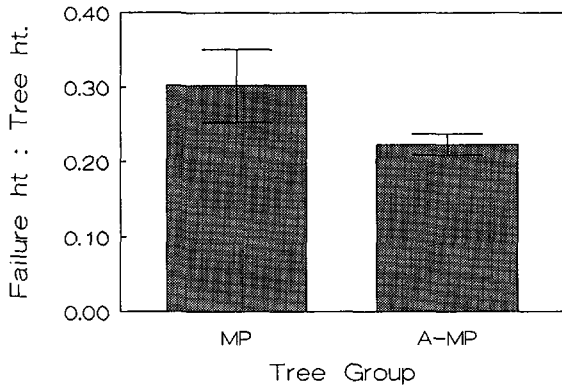
**Trunk failures.** Monterey pine trunk failures occurred relatively higher on the trunk than was typical for other trees in the database. The ratio of the height of trunk failure to the height of the tree for Monterey pine (.30) was greater than the mean for all other species combined as a group (.22, Figure 6). The ratio of the height of trunk failure to the height of the tree was used rather than failure height alone to compensate for the fact that Monterey pine is, on the average, a taller tree than most other landscape species in the database. The difference was significant at the 5% level for Monterey pine vs. all other species in an unpaired t-test.

**Figure 6. Ratio of trunk failure height (height above ground where failure occurred) to total height of tree. Comparison of Monterey pine (MP) with all other trees in the database (A-MP).**

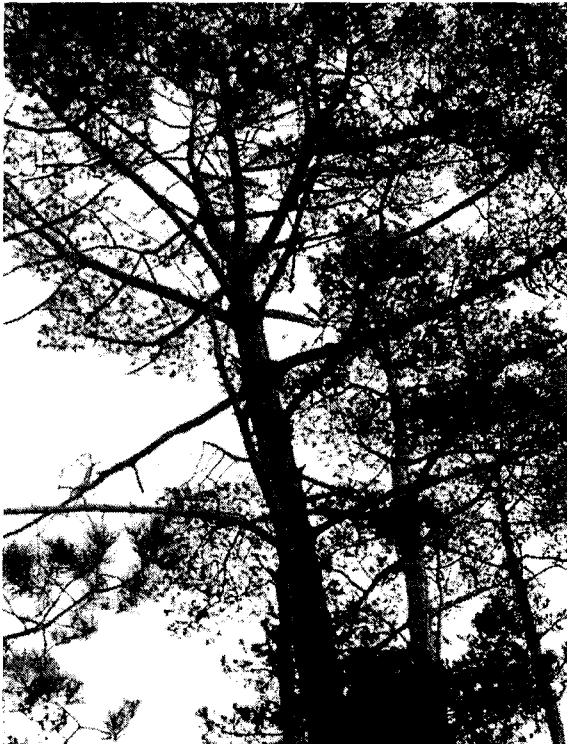
**Figure 7. Typical limb architecture of Monterey pine from native stand in Monterey, CA.**

Canopies with branches high on the trunk were common to both groups. Branches of trees in native stands had typical upper canopy branch diameters approximately one-half that of the trunk (Figure 7). In contrast, park trees commonly had

The lower trunk of the native Monterey pines had few branches (Figure 7), apparently as a result of shading out from earlier high stand densities. Park trees often had large diameter scaffold limbs (Figure 8) originating along the lower trunk (or pruning wounds indicating their previous presence).

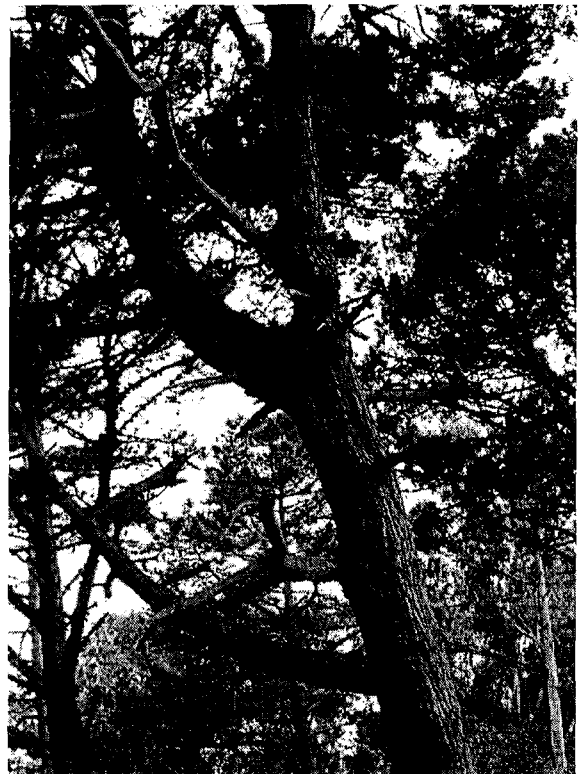
**Figure 8. Heavy lateral limb of Monterey pine from Golden Gate Park, CA.**

one to several lateral limbs (or codominant stems) whose diameter approached or exceeded that of the trunk diameter (Figure 8). The foliage appeared to be less dense in the native stands, possibly due to the shallow soil system, intermittent drought, and less nutrient availability. In both native stands and urban plantings, branch breakage seemed to occur most often out on the limb rather than at the trunk. Stubs left along the trunk were plentiful in both groups, generally 1 to 4 feet long. Several of those examined were broken at a dead secondary branch insertion point.

Arborists may reduce the incidence of heavy lateral limbs, codominant stems, and deformed trunks through careful attention to soil nutrition, particularly avoidance of excessive nitrogen (12). Interestingly, during the early years of tree establishment in Golden Gate Park, situated on a sand dune based soil, there was extensive use of "street sweepings" — including manure from the horse population in San Francisco at the time — as a soil amendment (4). This may have created site conditions conducive to development of large limbs and weak wood.
