PATTERNS OF STRUCTURAL FAILURE IN MONTEREY PINE

by Roger J. Edberg, Alison M. Berry and Laurence R. Costello

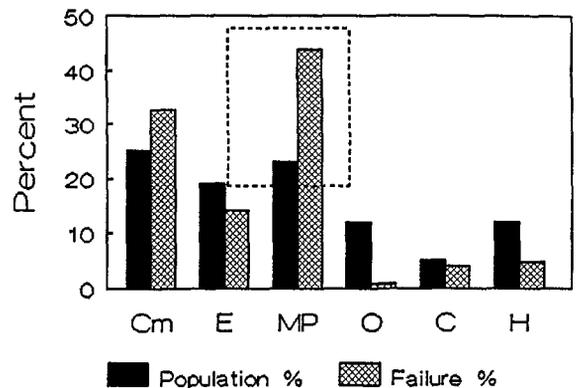
Monterey pines made up 23% of the Golden Gate Park tree population (1980 survey), yet 44% of all reported failures from Golden Gate Park were Monterey pine, substantially higher than the percentage in the park population (Fig. 1). Monterey cypress (*Cupressus macrocarpa*) failed at a rate somewhat higher than its percentage in the park population, while eucalyptus and oak species were reported to fail at a rate approximately equal to, or below their percentage in the population. When additional categories were created, i.e. "other conifers" (all conifers excluding

Figure 1. Comparison of tree failure frequency and population composition in Golden Gate Park, San Francisco, CA (CM = *Cupressus macrocarpa*, E = Eucalyptus species, MP = Monterey pine, O = oak species, C = conifers, H = other hardwoods).

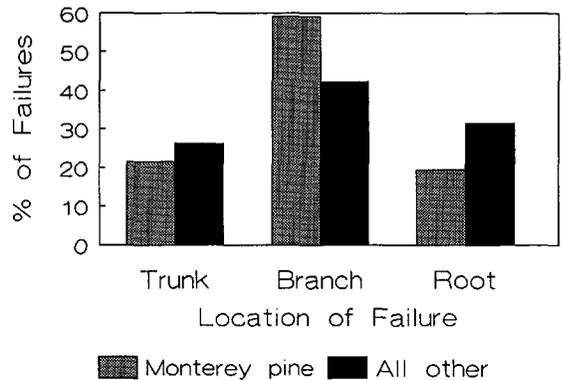
Characteristics of failure - branch. Monterey pine failures (Golden Gate Park and other combined) occurred most frequently at the branch (59%; Figure 2). Branch failures also form the largest category for all other species ("all other"). However, the frequency of branch failure for Monterey pine is significantly greater than for other species (chi-squared, $P=.00$). The sample population was greatly influenced by the predominance of reports from Golden Gate Park trees. Still, the branch failure rate for Monterey pine trees reported from other areas outside the park was significantly higher than that for all other trees in the database grouped together (51% vs 42%, chi-squared, $P=.03$) (Table 1).

Figure 2. Type of failure by location on the tree (trunk, branch, or root). Comparison of Monterey pine and all other trees in the database.

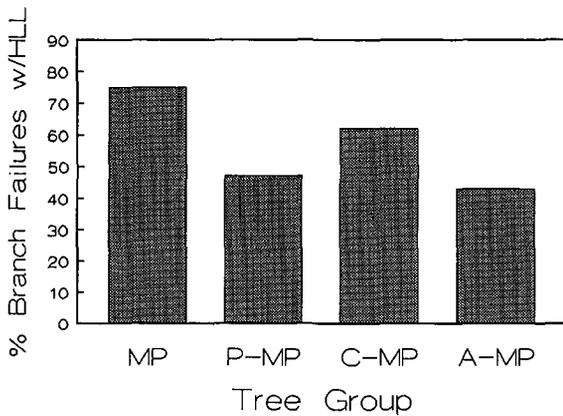
Heavy lateral limbs (HLL) were associated with 75% of all Monterey pine branch failures (MP, in Figure 4). This is nearly double the rate of association of heavy lateral limbs with branch failures for all other species as a group, excluding Monterey pine (43%, A-MP). Other pine species (P-MP) and other conifers in general as a group (C-MP) also

had lower rates of association (47% and 61% respectively). The high association of heavy lateral limbs with Monterey pine branch failure was consistent for failure reports from Golden Gate Park, and from other locations (Table 1). Surprisingly, the average branch diameter for HLL-associated failures was only 12". Long branches, branches with a heavy foliage load, and branches with a heavy cone load may have been included in this category for Monterey pine.

Figure 4. Heavy lateral limbs (HLL) as a structural defect associated with failure. Comparison of Monterey pine (MP) with other pines (P-MP), all conifers except Monterey pine (C-MP), and all other trees in the database (A-MP).

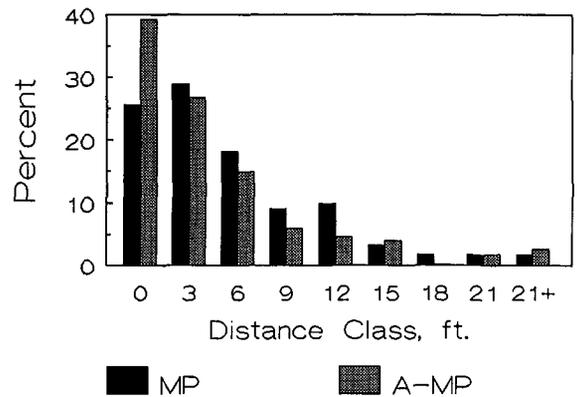
The location of branch failure ranged from the point of attachment with the main trunk to 25 feet out on the branch (Figure 5). Failure occurred flush with the trunk in 26% of all Monterey pine (MP) branch failure reports, while 74% occurred away from the point of attachment. This pattern suggests that most Monterey pine branch failures are not the result of a weak attachment but rather arise from some problem with wood strength or load distribution. Branch failures for all other species (A-MP) in the database grouped together occurred at the attachment in 39% of the reports and out on the branch 61% of the time. A cross-tabulation of branch failures at the attachment or not between Monterey pine and all other species as a group results in a chi-squared probability of .05.

Figure 5. Branch failures: Distance of break site from point of attachment to trunk (attachment = 0 ft., 1-3 ft. class = 3, 4-6 ft class = 6, etc.). Frequency of branch failures per distance class for Monterey pine (MP) and all other species combined (A-MP).

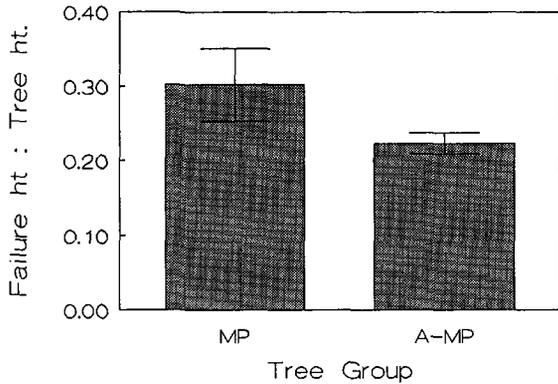
Trunk failures. Monterey pine trunk failures occurred relatively higher on the trunk than was typical for other trees in the database. The ratio of the height of trunk failure to the height of the tree for Monterey pine (.30) was greater than the mean for all other species combined as a group (.22, Figure 6). The ratio of the height of trunk failure to the height of the tree was used rather than failure height alone to compensate for the fact that Monterey pine is, on the average, a taller tree than most other landscape species in the database. The difference was significant at the 5% level for Monterey pine vs. all other species in an unpaired t-test.

Figure 6. Ratio of trunk failure height (height above ground where failure occurred) to total height of tree. Comparison of Monterey pine (MP) with all other trees in the database (A-MP).

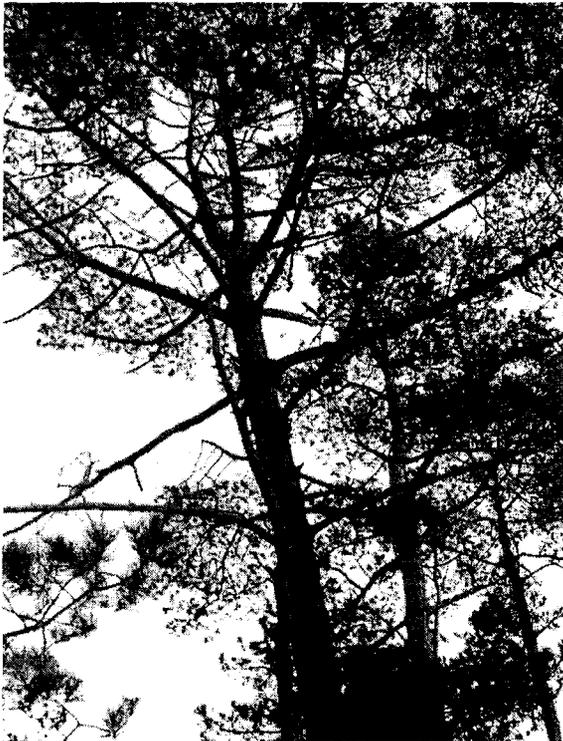
Figure 7. Typical limb architecture of Monterey pine from native stand in Monterey, CA.

Canopies with branches high on the trunk were common to both groups. Branches of trees in native stands had typical upper canopy branch diameters approximately one-half that of the trunk (Figure 7). In contrast, park trees commonly had

The lower trunk of the native Monterey pines had few branches (Figure 7), apparently as a result of shading out from earlier high stand densities. Park trees often had large diameter scaffold limbs (Figure 8) originating along the lower trunk (or pruning wounds indicating their previous presence).

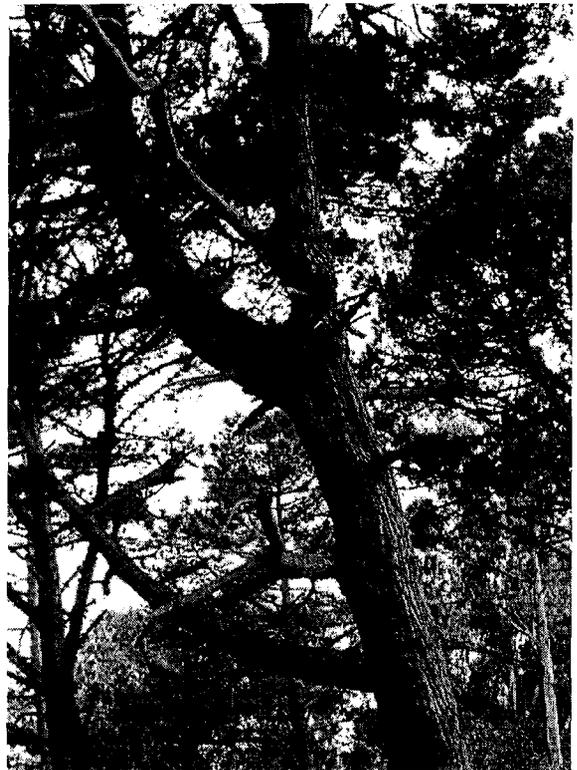
Figure 8. Heavy lateral limb of Monterey pine from Golden Gate Park, CA.

one to several lateral limbs (or codominant stems) whose diameter approached or exceeded that of the trunk diameter (Figure 8). The foliage appeared to be less dense in the native stands, possibly due to the shallow soil system, intermittent drought, and less nutrient availability. In both native stands and urban plantings, branch breakage seemed to occur most often out on the limb rather than at the trunk. Stubs left along the trunk were plentiful in both groups, generally 1 to 4 feet long. Several of those examined were broken at a dead secondary branch insertion point.

Arborists may reduce the incidence of heavy lateral limbs, codominant stems, and deformed trunks through careful attention to soil nutrition, particularly avoidance of excessive nitrogen (12). Interestingly, during the early years of tree establishment in Golden Gate Park, situated on a sand dune based soil, there was extensive use of "street sweepings" — including manure from the horse population in San Francisco at the time — as a soil amendment (4). This may have created site conditions conducive to development of large limbs and weak wood.
