# TREE ROOTS IN SEWER SYSTEMS IN MALMO, SWEDEN

by Kaj Rolf and Örjan Stål

**Case Study: Malmö, Sweden**

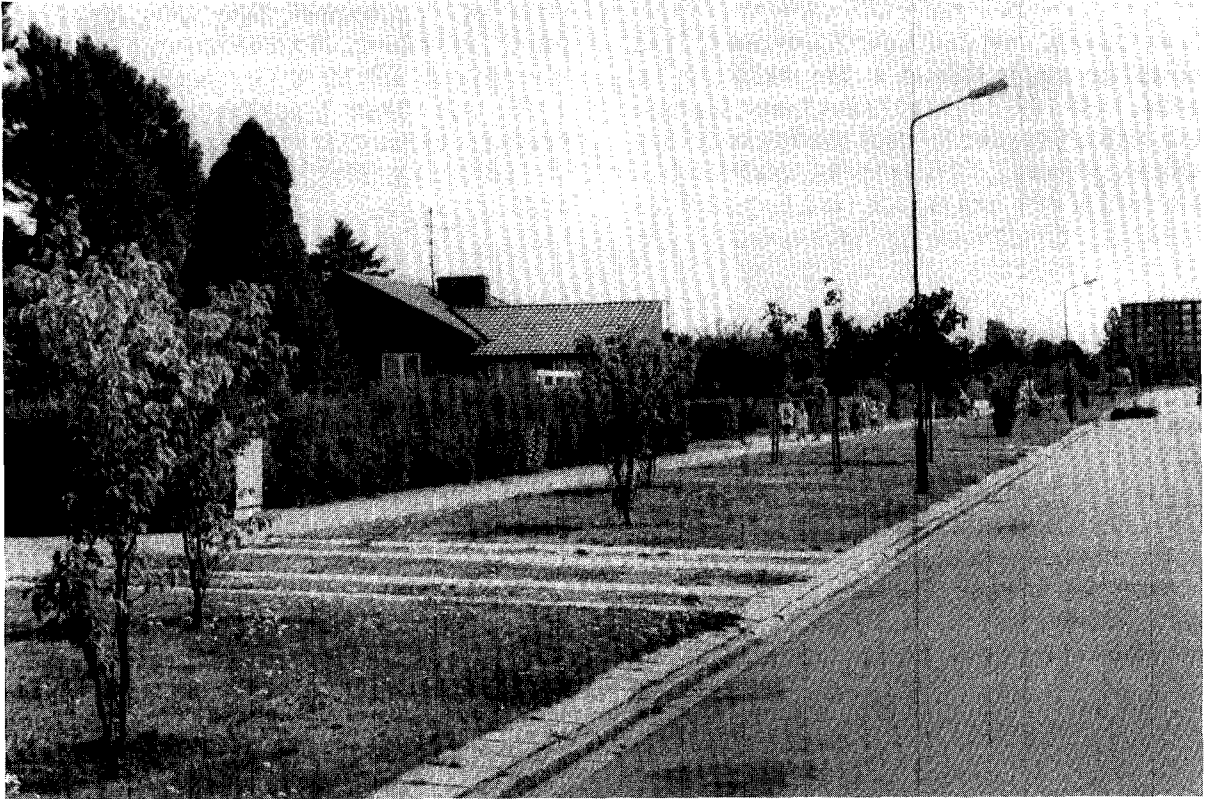
**Figure 8.** Vanåsgatan one year after replanting with *Acer platanoides* 'Schwedleri' where there was enough space and with *Cercidiphyllum japonicum* and *Prunus sargentii*.

Decision, use alternative 3. This meant that all willows were taken down and new trees were planted. The species chosen were maple, *Acer platanoides* 'Schwedleri' where there was enough space and *Cercidiphyllum japonicum* and *Prunus sargentii* in groups according to Figure 8, which shows the street one year after replanting.
