PRESERVATION OF A LARGE CHINESE BANYAN ON A CONSTRUCTION SITE

by C.Y. Jim

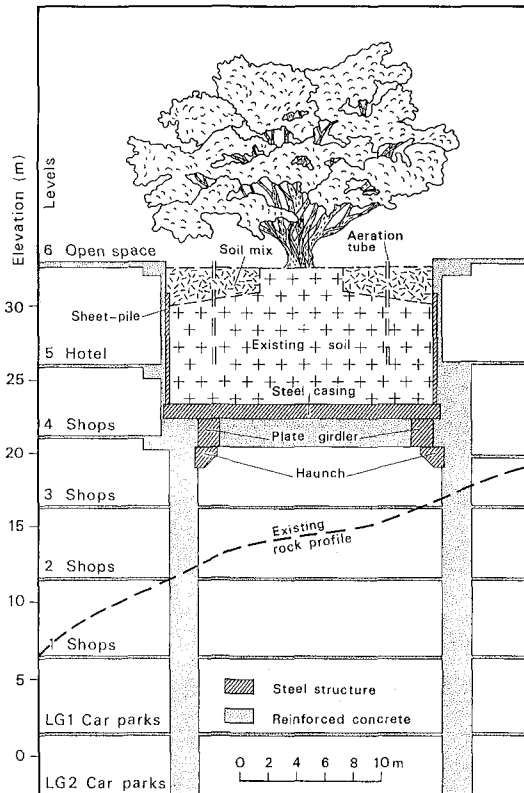
Engineering measures. The retention of the tree was complicated by the developer's intention to build five stories (shops and car parks) below the tree (Fig. 3). In essence, a huge concrete planter 10m deep and 18m diameter was constructed to contain the rooting soil mass and was thus detached from the surroundings. Engineering procedures were started after root pruning and other arboricultural attentions (see next section). Initially, contiguous sheet-piles were inserted vertically around the 18m-diameter perimeter as temporary support (Fig. 1). The piles were driven in short sections to avoid damaging the crown. Five caissons were then excavated outside the piles, and reinforced-concrete columns were cast inside

The soils around the sheet-piles were removed to allow contiguous hollow steel casings to be driven horizontally into the bottom of the enclosed soil mass. The soils inside the casings were bored out and prefabricated steel beams inserted. The spaces between the casing and beam were grouted with concrete. Excavation under and around the new floor-slabs provided room to install steel plate girders and haunch brackets which were linked to the supporting columns (Fig. 3). Finally, reinforced concrete beams were cast below the floor-slabs and walls encircling the sheet-piles to give a permanent shell to the planter. Drainage pipes and outlets were installed at the bottom. Thereafter, the top-down construction of basement floors could proceed while the tree was protected by sufficient hoardings against

Figure 3. Engineering measures adopted to create a huge concrete planter. The steel structures provide temporary supports whereas the reinforced concrete provide the permanent casing for the planter. Construction proceeds top-down from the bottom of the planter (Source: adapted from diagram supplied by contractor).

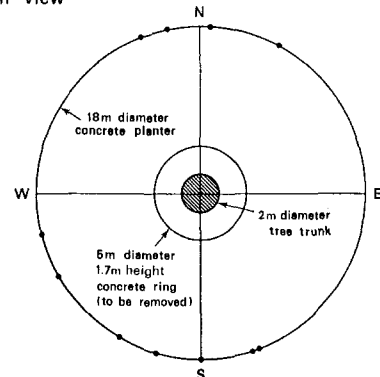
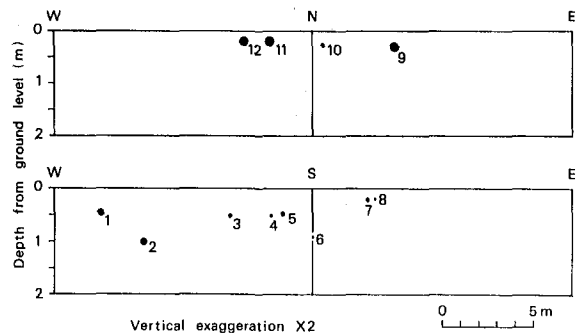
Arboricultural considerations. In preparation for root containment, dead, broken, and diseased wood was removed from the tree and cable bracing was installed to support the trunk and main branches. In addition, an irrigation basin was made and gravel-filled aeration tubes and an irrigation system were installed. Roots were pruned at approximately the drip-line in two stages to minimize shock. The initial trench, 0.75m wide by 1.5m deep, was followed after two months by a larger trench of 1.5m wide by 2.5m deep. To stimulate fibrous-root growth (3) trenches were immediately refilled with coarse materials. Root distribution and size above 10mm diameter in the trenches were recorded at the time of trenching and are plotted in Fig. 4. All roots greater than 10 mm were found in the top 1m of soil, indicating that the planter was adequate for the tree at present. The large

Figure 4. Distribution of roots over 10mm diameter on the walls of the root-pruning trenches. Note the concentration of roots in the top 1m of the soil, and the paucity of roots at the 18m perimeter (Source: adapted from diagrams supplied by contractor).
