TREE ROOTS IN SEWER SYSTEMS IN MALMO, SWEDEN

by Kaj Rolf and Örjan Stål

Abstract. Three sites with root intrusion problems in the City of Malmö were inspected to find different solutions to the problems. All sites had high maintenance costs due to the roots. Alternative measures for each site were selected. Each site was treated differently depending on the technical, aesthetic, cultural and economical values. At one site, pipes were relined, at another the trees were replaced with less aggressive species and at the third a decision is yet to be made.

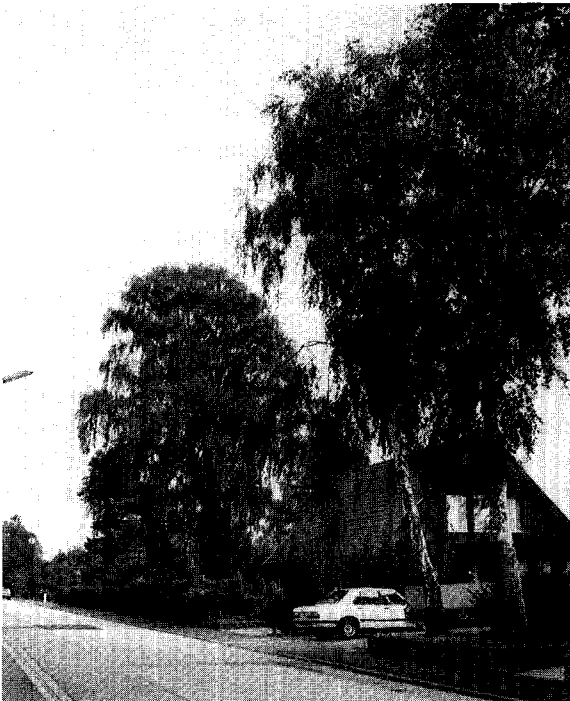
Kungshällagatan is a street in a residential area built between 1954 and 1956. The sewer line is a combined sewer located in the middle of the street. Unlike the other two areas, the problems in this area are caused by trees growing on private property (Figure 7). The part of the street that had the most severe root intrusion is a section about 80 m long. Along this section there are some large birches in the private gardens. This means that the service connections were 2-4 meters and the sewer line was 4 meters from the trees.

Figure 7. Kungshällagatan is a street built between 1954 and 1956. The sewer line is a combined sewer located in the middle of the street. The problems in this area were caused by trees growing on private property.

with yarn and cement. Tree roots can easily penetrate the joints. The maintenance costs were calculated to SEK 90 (\$ 11) / meter each year.

The soil. Since the trees were on private property, no actual soil examination was made. The trees were very close to the street and tree roots must have followed the pipe trench out into the street.

Decision, none at this time.
