TRANSPLANTING TWO CHAMPION SPECIMENS OF MATURE CHINESE BANYANS

by C.Y. Jim

Abstract. Recent expansion of a urban-situated racecourse in Hong Kong proposed felling two champion specimens of mature Chinese Banyans (*Ficus microcarpa*). In response to public outcry, they were transplanted at great cost to a nearby site. The arboricultural-cum-engineering measures used to move the large trees, an unprecedented operation locally, are explained. The hydraulic approach conveying the trees held in 8 m diameter steel containers running on rails was workable but expensive. The impacts on the trees, and implications on the community's attitude towards trees and their welfare, are discussed.

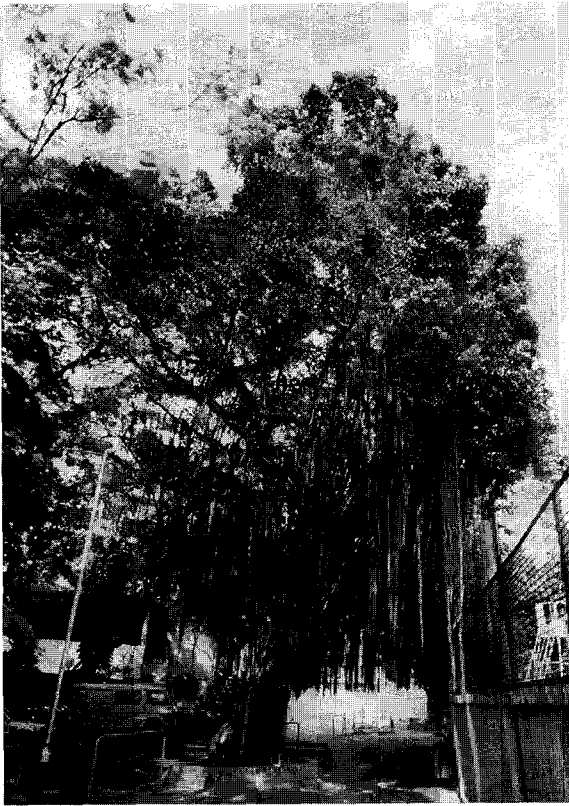
Figure 1. The beautiful tree A situated in a tree pit on the edge of the footpath in Sports Road photographed before crown reduction. Note the unusually abundant growth of aerial roots which bestow a unique character to the specimen.

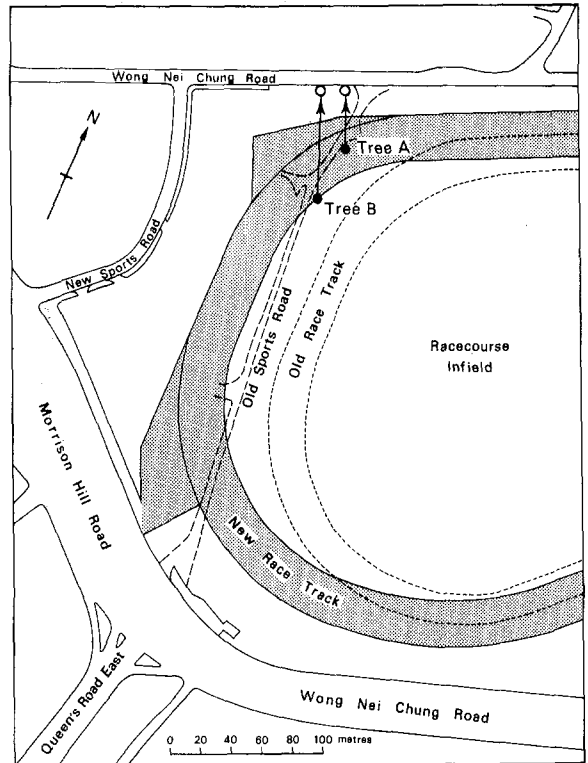
Figure 2. The original and destination locations of the two transplanted Chinese Banyans. Note the alignment of the old and new race tracks in relation to tree positions, and the new Sports Road.

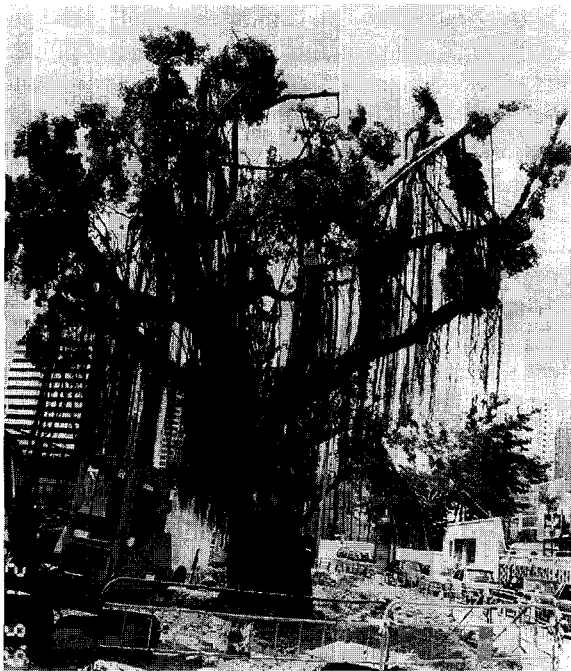
Figure 3. Tree A shortly after massive crown reduction. Note the loss of most foliage and twigs, and cutting down to major branches and limbs.

The removal of over half of the crowns was perhaps unnecessary. Moreover, the reduction method is more like pollarding than a less destructive crown reduction and thinning. Cutting was made down to major branches and even limbs. The need to balance root losses by substantial top removal so as to regain the root:shoot balance (11) seems to have been overdone. The need for excessive reduction has been cast in doubt (9). The disfigured tree form is unlikely to be re-gained. The loss of the majestic curtain of aerial roots in tree A has robbed the tree of its very charm and character. The resprouting even before the transplant (compare Figures 3 and 4) shows a unnatural shape. Whereas the yet unsevered roots might have provided the nutrients, some of

Crown reduction preceded root pruning. About half of the crown was removed quite drastically, including major branches and limbs (Figure 3). A sprinkler system to produce a fine mist was installed in the crown to reduce foliage temperature and dampen transpiration. The trunk and limbs were wrapped with hessian to lower temperature and the possibility of mechanical injury. Root pruning was phased over four stages, each dealing with a quarter, over two growing seasons (1993 and 1994). A 2 m deep and 1 m wide trench was dug manually at 4 m from the trunk, regarded as deep enough to encompass most roots, since Banyan

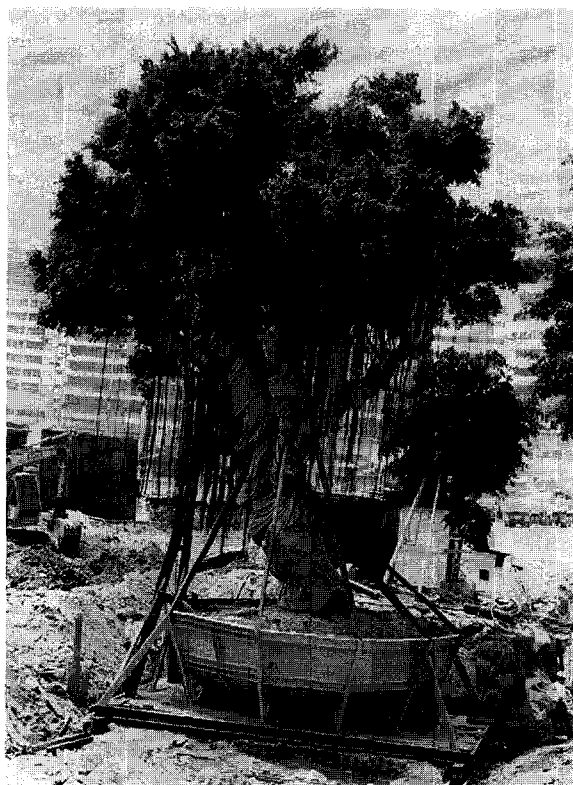
Figure 4. Tree A about 18 months after crown reduction. Note the regrowth of some foliage mainly as sprouts from cut faces, the base plate supporting the steel container, and the beams propping the tree.

reduction managed to trim only a small proportion of the load. Lifting was ruled out, and so the sledge method was adopted. Customary wrapping of the rootball using hessian or a wooden box could not handle the weight. A high-strength steel encasement was necessary instead. A container using 4 mm steel sheet reinforced by steel tubes, all welded together, was constructed at the time of root pruning (Figure 4).

The loss of stability due to root severance was compensated by propping with steel beams attached to the upper edge of the container. The interfaces between steel and wood were cushioned by high-density rubber mats. The supports were essential because of the possibility of typhoons in Hong Kong.

channel was excavated to connect the old and the new tree sites. Due to a difference in elevation of 2.1 m, the channel had to rise towards the destination. A 9 m square base plate was then inserted underneath the container (Figures 4 and 5). The original plan was to winch a cable below the container and insert U-shaped steel sections. Instead, a high-pressure water jet was employed to tunnel the sandy soil of loose consistence. Steel beams were inserted one by one contiguously to form the base plate. Props, connecting the base plate to the container wall and to the tree, were added to provide more support (Figure 4).

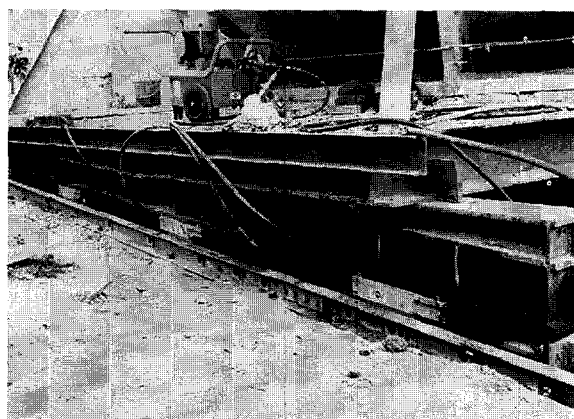
Figure 5. One of the two angled sledge units that wedge below the base plate. Note the four hydraulic shoes which continuously level the tree, and the rail on which they rest.

As the trees had to climb a slope of 8% and 4% respectively, two more sets of beams with an oblique bottom corresponding to the slope angle (Figure 5) were added. They were fixed under the two sides of the base plate parallel to the moving direction, and served as the sledges on which the whole set-up would be pushed.

To balance the trees during conveyance, eight hydraulic shoes were installed at the bottom of the sledges (Figure 5) for gimbals-like continuous leveling adjustment. The bottom of the shoes were made of bronze and lubricated to facilitate the sliding on the rails. To ensure a smooth ride, the rails must be built parallel to each other and run on a constant gradient. The two hydraulic jacks had to be pushed at the same rate. At a designated speed of 6 meters per hour, the travel was completed within a day.

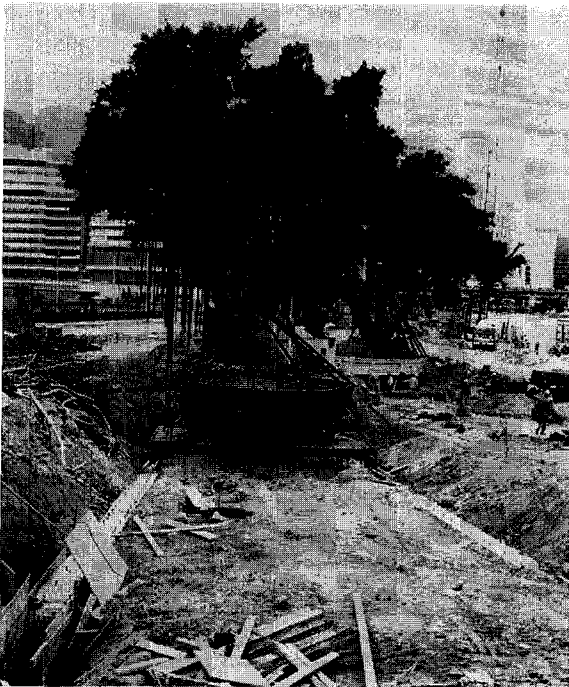
Figure 6. Tree A on the left and tree B on the right behind it immediately before the transfer. Note the construction of reinforced concrete rail bedding on which the tree would slide on rails towards the destination.

The trees were ready to move in March 1995. The original idea of using rollers below the base plate and pulling by tractors was not used. An hydraulic approach was adopted instead. The trees were to ride on rails and be pushed by hydraulic jacks. For each tree, two rail bedding made of reinforced concrete with embedded bolts were built (Figure 6). Steel rails were then fixed

onto the bolts, and the set-up was pushed at the back (downslope side) by two powerful hydraulic jacks each capable of generating 38 Mg.
