Decay Detection in Red Oak Trees Using a Combination of Visual Inspection, Acoustic Testing, and Resistance Microdrilling

Xiping Wang and R. Bruce Allison

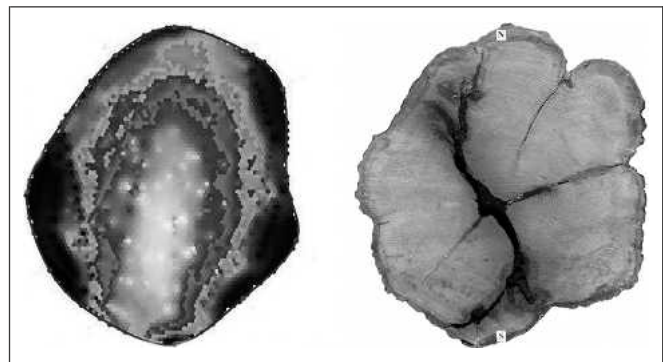
For red oak No. 123, the visual inspection revealed trunk seams and cracks with cankering on the south side with associated *Ustulina deusta* fungus. The single-path stress wave tests revealed a stress wave transmission time ranging from 1908 to 2320 $\mu\text{s}/\text{m}$ (581 to 707 $\mu\text{s}/\text{ft}$). The tomography revealed a large area of defect. The Resistograph drilling revealed a large snake-shaped crack. Figure 2 shows the comparison of the acoustic tomograph and photograph of the cross-section for red oak No. 123.

Figure 2. Comparison of acoustic tomograph and photograph of the cross-section for red oak tree No. 123.
