Decay Detection in Red Oak Trees Using a Combination of Visual Inspection, Acoustic Testing, and Resistance Microdrilling

Xiping Wang and R. Bruce Allison

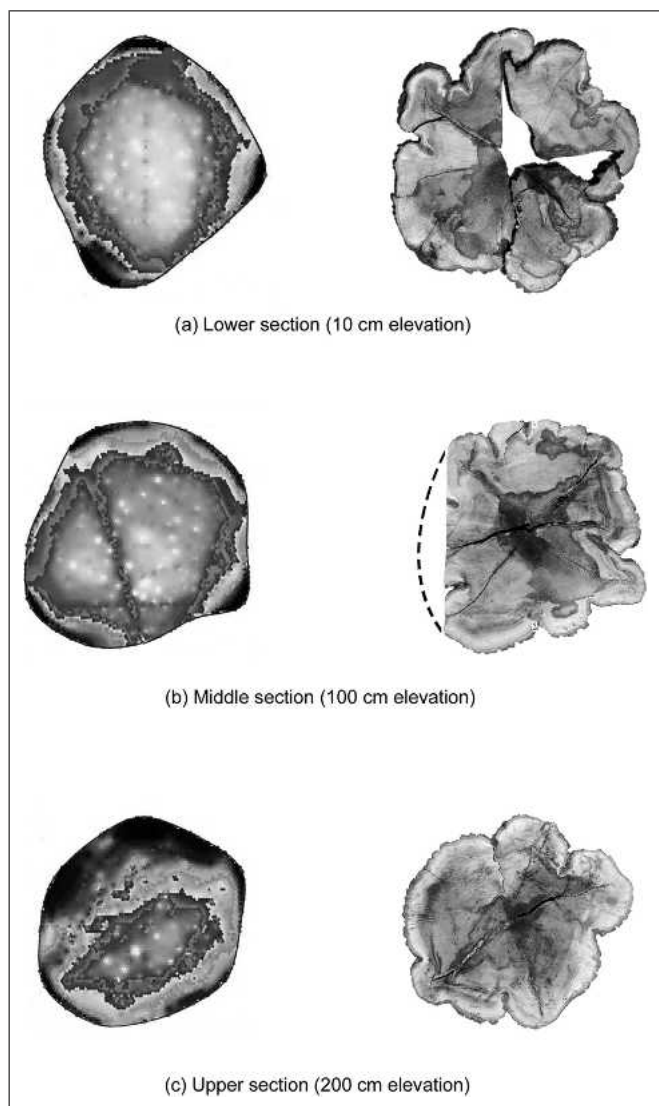
After being cut down, tree No. 307 was found to have heartwood decay at all three elevations. Laboratory examination confirmed the presence of white rot decaying fungus. The decay was less severe in the upper cross-section (200 cm [80 in] elevation), but it increased in size as the elevation dropped.

In addition to decay, major internal cracks were present in the cross-sections of tree No. 307. The combination of extensive decay and large lateral cracks caused the base disk to fall into several pieces during transportation. The photographs of the disks show that lower and middle cross-sections had multiple lateral cracks and the upper cross-section had one large lateral crack.

Figure 1 shows the comparisons of acoustic tomographs and photographs of the cross-sections at three elevations for red oak No. 307. The dark-colored zones (brown if it is in color print) in the tomograms represent solid wood, and the light-colored zones represent potentially decayed wood (if displayed in color, the tomograms use green, violet, and blue to represent increasing degradation by decay). It is clear that the tomographs show a strong correspondence to the images of the disks. Extensive decay and radiating lateral cracks in the lower and middle cross-sections were reflected by large light-color zones in the tomographs. The tomograph of the upper cross-section accurately located the position and orientation of the big lateral crack and heartwood decay.

Figure 1. Comparison of acoustic tomographs and photographs of corresponding cross-sections for red oak tree No. 307.
