STREET TREE INVENTORY IN MEXICO CITY

by Alicia Chacalo, Alejandro Aldama and Jaime Grabinsky

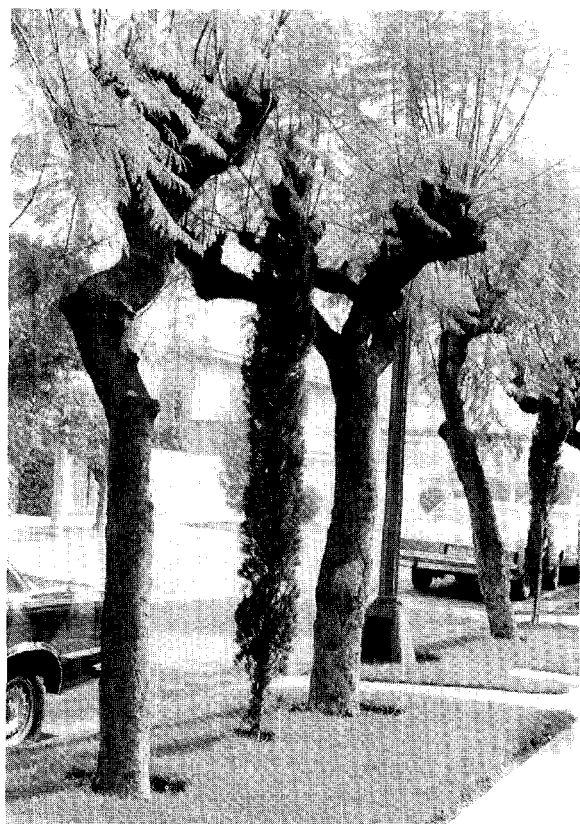
Fig. 1. Trees in a sidewalk in Mexico City that were measured and evaluated.

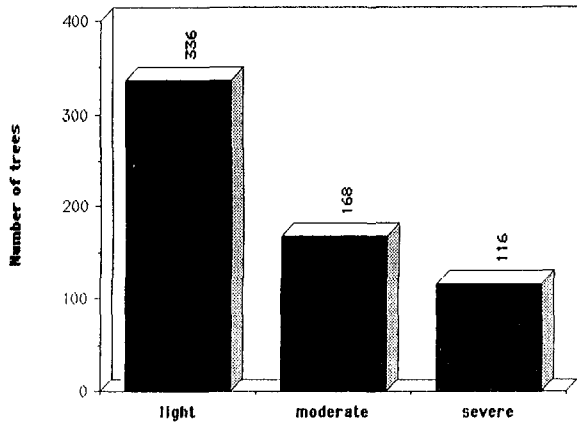
Diseases affected more than half (644) of the trees sampled (Fig.7) which is about the same number of trees presenting injuries due to insects (Fig.8). Severe injuries and diseases, were found on approximately 10% of the trees. More wounds were found (1827) than the total number of trees

Fig. 8. Distribution of the number of injuries due to insects.

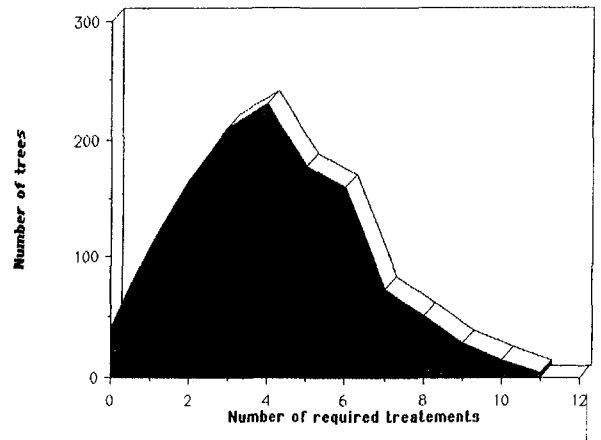
Fig. 10. Distribution of the number of trees with respect to number of required treatments.

Pruning was required in almost all the trees and in more than half it should be done within the coming year at the most (Fig.9). There were several other required treatments; the total number per tree was over four in average (Fig.10).
