JOURNAL OF ARBORICULTURE

May 1984
Vol. 10, No. 5

PARKWAY TREE AUGERING SPECIFICATIONS¹

by John D. Morell

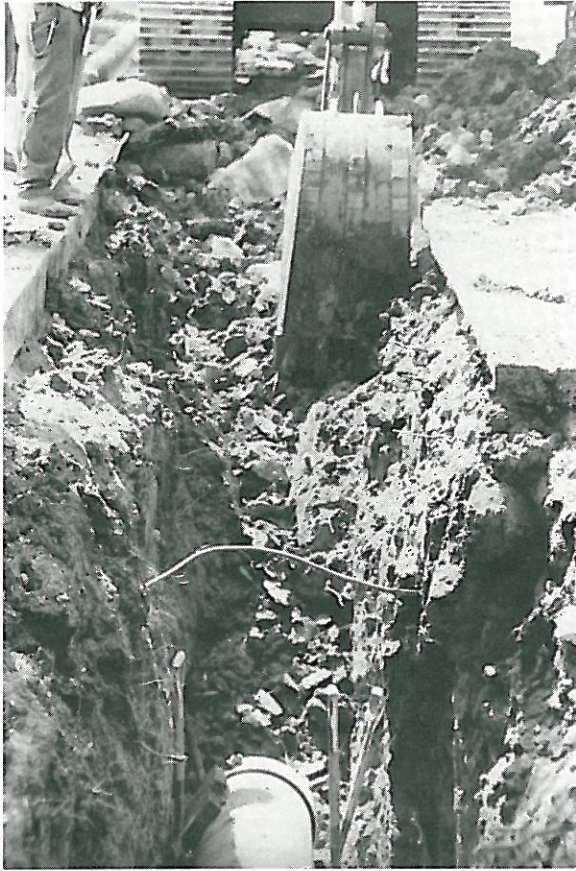
Fig. 2. Construction damage to the root system of a parkway tree during installation of a sewer.

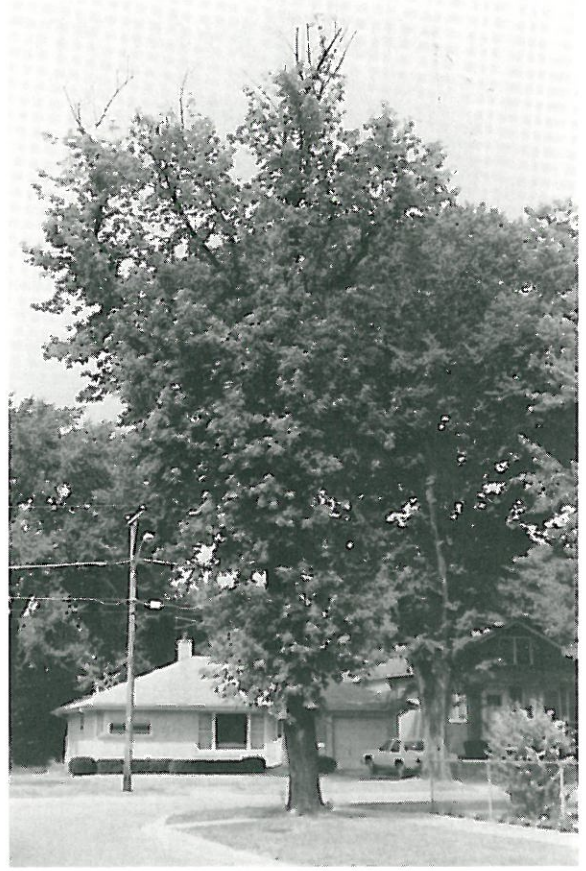
The 1971 construction area contained 135 parkway trees. We recorded the presence or absence of trees, current tree condition (particularly noting top dieback), trunk damage and/or the presence of trunk cavities or decay. The survey revealed that 60 trees had been removed, a 44 percent loss, and 13 trees had significant dieback in their crowns. The 1972 project contained 127 parkway trees. Of these 32 trees no longer existed, a 25 percent loss, and 14 trees had crown dieback. These results confirmed what we already knew, that there was significant damage to the parkway trees as a result of trenching through the root zone during the installation of

Fig. 3. Top dieback damage caused by trenching through the root system in 1972 to install a water main in the parkway.

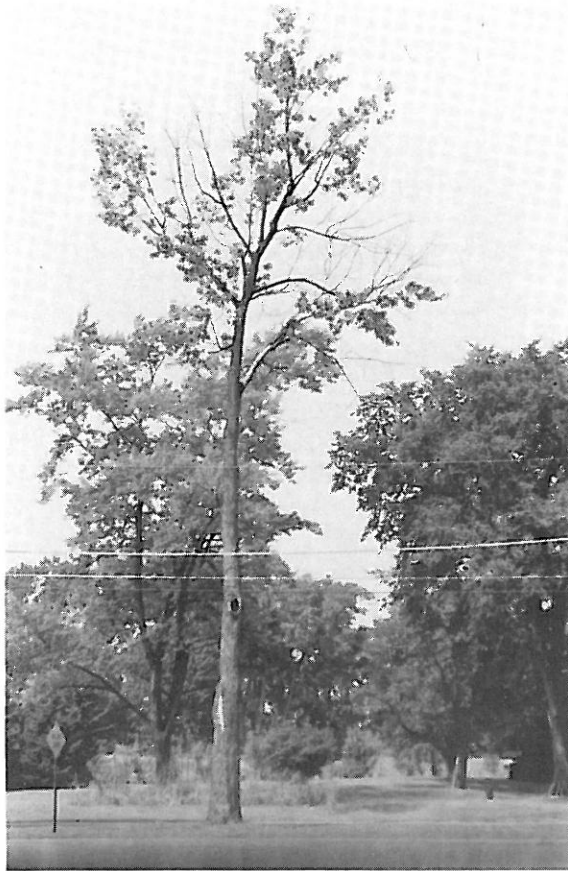
Fig. 4. Tree decline and top dieback resulting from trenching in the parkway in 1972.

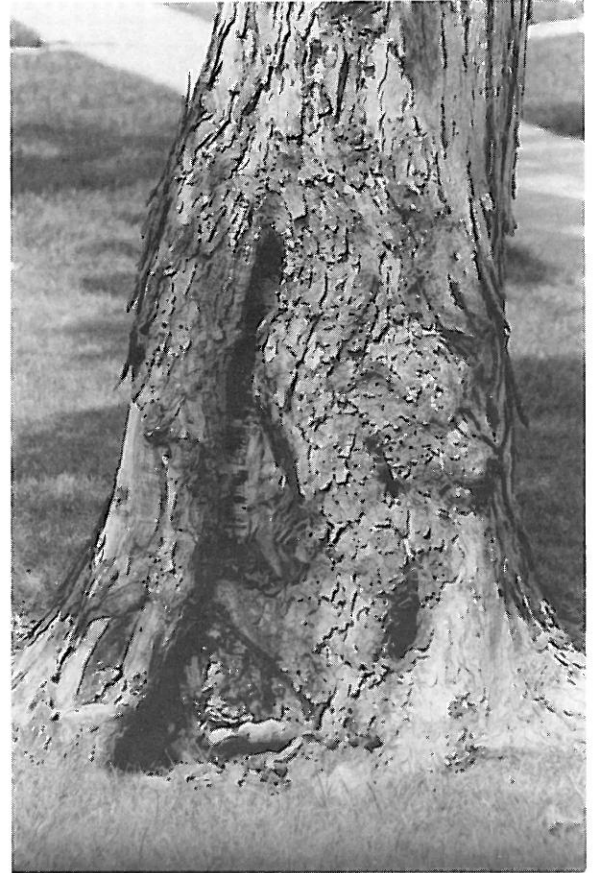
Fig. 5. Trunk damage caused by careless construction workers while installing a water main in the parkway.
