STREET TREE INVENTORY IN MEXICO CITY

by Alicia Chacalo, Alejandro Aldama and Jaime Grabinsky

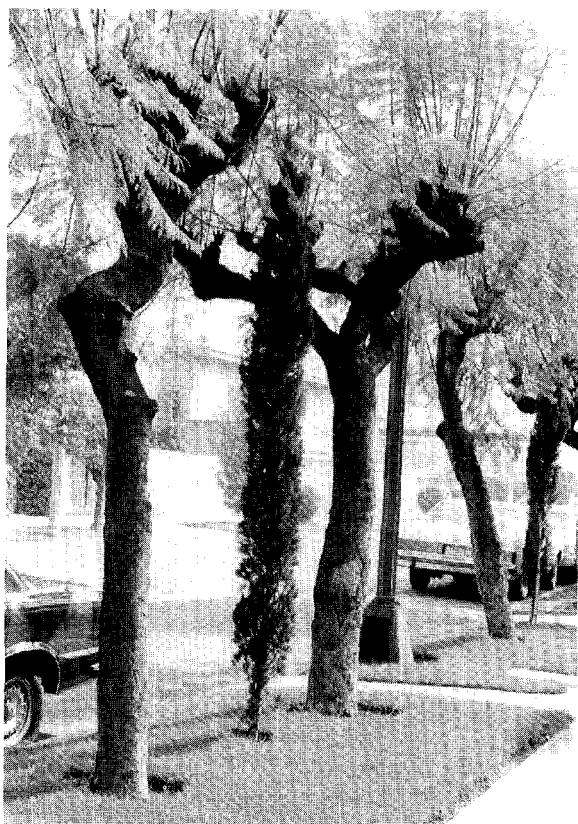
Fig. 1. Trees in a sidewalk in Mexico City that were measured and evaluated.

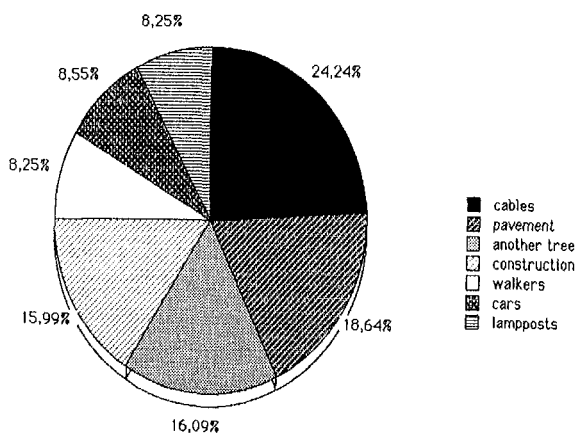
Site evaluation. Among the variables considered as tree interferences, electric and telephone lines and pavement were the most frequent (Fig.2). Utility lines were in 48% of the trees and were 24% of all the interferences. Pavement accounted for 19% of the interferences but affected 37% of the trees. Many trees had two or more interferences that required immediate attention.

Fig. 2. Distribution of tree interferences.

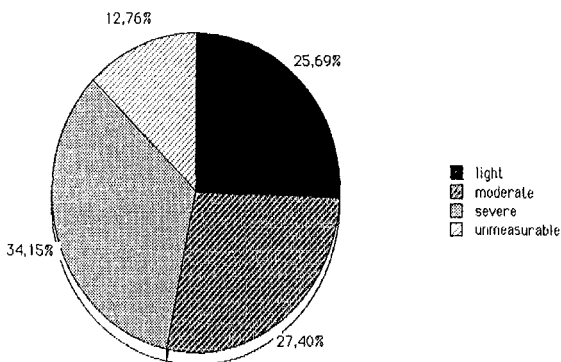
The soil compaction around 13% of the trees could not be measured using the iron rod technique (Fig.3), and for another 34% it was severe. In all, 47% of the individuals were affected strongly by this problem. From all site measurements and observations, approximately 20% of the trees live

Fig. 3. Soil compaction.

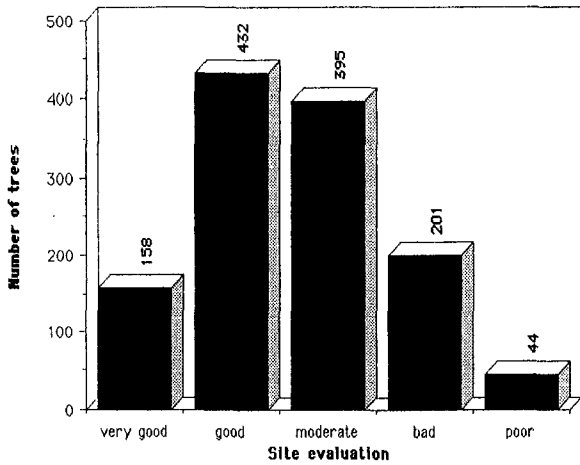
Fig. 4. Distribution of the number of trees with respect to site evaluation.

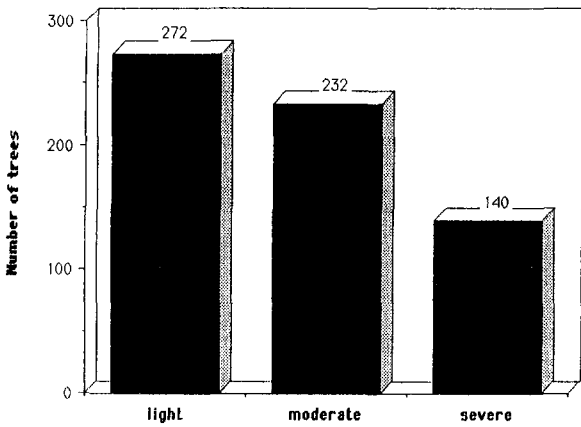
Diseases affected more than half (644) of the trees sampled (Fig.7) which is about the same number of trees presenting injuries due to insects (Fig.8). Severe injuries and diseases, were found on approximately 10% of the trees. More wounds were found (1827) than the total number of trees

Fig. 7. Distribution of tree disease intensity.

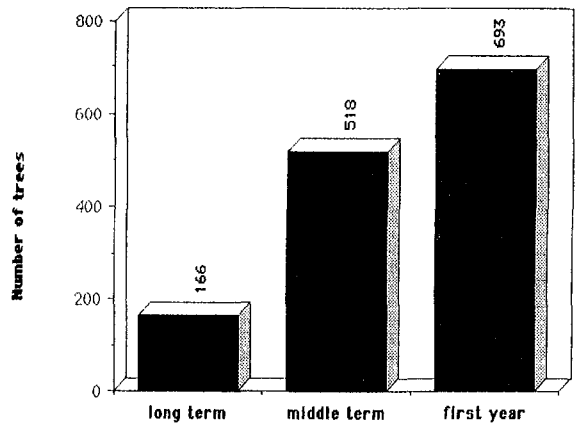
Fig. 9. Recommended pruning.

Pruning was required in almost all the trees and in more than half it should be done within the coming year at the most (Fig.9). There were several other required treatments; the total number per tree was over four in average (Fig.10).

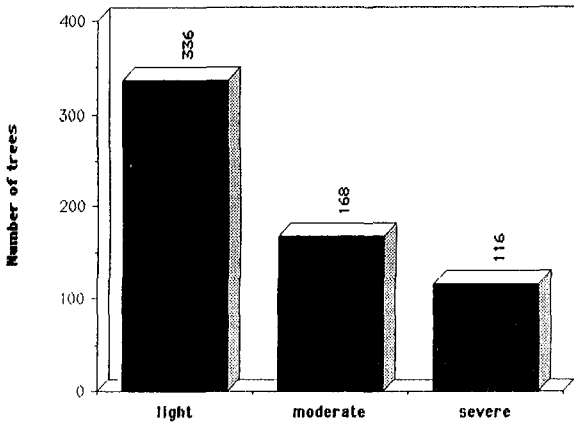
Fig. 8. Distribution of the number of injuries due to insects.

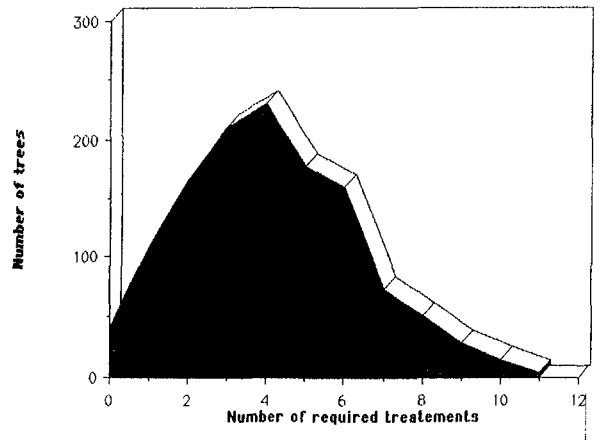
Fig. 10. Distribution of the number of trees with respect to number of required treatments.
