Research Note

PRELIMINARY EVALUATION OF A LIVING WILLOW (*SALIX* SPP.) SOUND BARRIER ALONG A HIGHWAY IN QUÉBEC, CANADA

By Michel Labrecque and Traian Ion Teodorescu

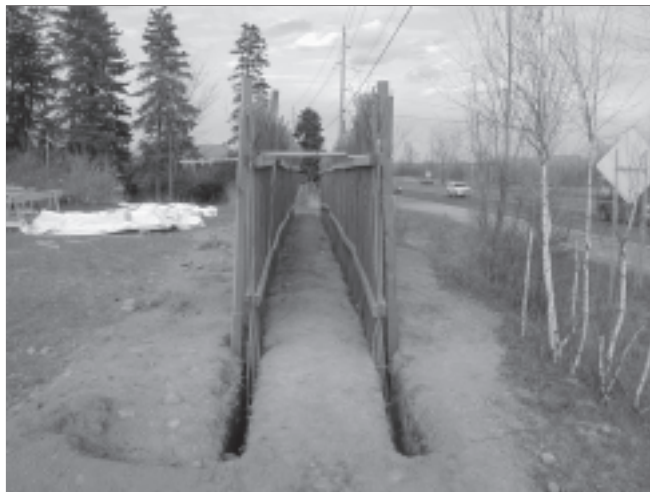
Figure 2. Stems are assembled tightly in a wooden frame and installed upright in two trenches set 1.2 m (4 ft) apart.

The construction was set up in April, as soon as the ground had thawed out. Following transport to the construction site, stems were quickly assembled tightly in the wooden frame and installed upright in two 1 m (3.3 ft) deep trenches set 1.2 m (4 ft) apart. The two willow walls were solidly held together by wood pieces and steel rods (Figures 1 and 2). A permeable, 2.5 m (8.2 ft) wide, thin geotextile was fastened inside over the entire length of the wall. The trenches were filled with a sandy-textured soil. A tractor equipped with a front loader was used to fill the space (with the same soil) between the two walls up to a height of 2.5 m (8.2 ft). At the end, a perforated irrigation hose connected to the municipal aqueduct was fixed at the base of the stems (20 cm [8 in.] above ground level) throughout the two sides of the wall. Once finished, the wall was 30 m (98 ft) long, 1.2 m (4 ft) wide, and 2.5 m (8.2 ft) high. More details about the construction of the wall are given in the patent description (Freitag 2001).

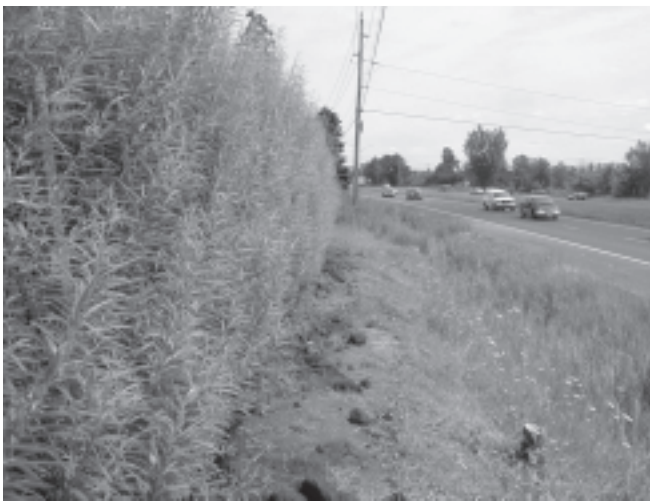
Figure 3. About 8 weeks after establishment, the wall was completely green.

Three weeks following the construction of the wall, opening buds and expanding shoots were observed at first on the south of the wall but, soon after, the stems on the north side also started to grow. About 8 weeks after establishment, the wall was completely green (Figure 3). Table 1 presents the characteristics measured on stems of each side of the wall at the end of the first growing season. The statistical analysis (ANOVA) of the data collected did not highlight any significant differences between the parameters measured on both sides of the wall. The average number of new branches developing on stems varied between 5.54 and 6.45, and they were almost equally distributed along the entire stem. At the end of summer, the newly developed branches reached almost 2 m (6.6 ft) in height, forming a wall 4.5 m (15 ft) high. The dry biomass of the newly developed branches was 2.17 kg (4.8 lb) and 1.93 kg (4.3 lb) per linear meter on the south and the north sides, respectively.
