# EFFECT OF BASEMENT SUMP PUMP EFFLUENT ON THE GROWTH AND PHYSIOLOGY OF URBAN BLACK ASH AND GREEN ASH ORNAMENTAL TREES

by Cameron G. Lait<sup>1</sup>, Suomal Saelim<sup>2</sup>, Janusz J. Zwiazek<sup>2</sup>, and Yao Zheng

**Abstract.** The effect of basement sump pump effluent discharge in proximity to boulevards and ornamental trees was studied at several sites near Edmonton, Alberta, Canada throughout the summer of 1996. The growth, leaf petiole water potentials, and gas exchange of black ash (*Fraxinus nigra*) and green ash (*F. pennsylvanica*) trees were measured at sites with and without nearby sump pump effluent discharge. Black ash trees had higher mortality, altered water relations, and significantly lower caliper increase at the site with sump pump effluent discharge compared to trees at the site without effluent discharge. Green ash trees situated away from sump pump effluent discharge had significantly greater caliper increase than trees situated near effluent discharge. Furthermore, salt injury symptoms were observed on both species of trees located at sites with nearby effluent discharge. Our results demonstrate the importance of monitoring sump pump effluent discha

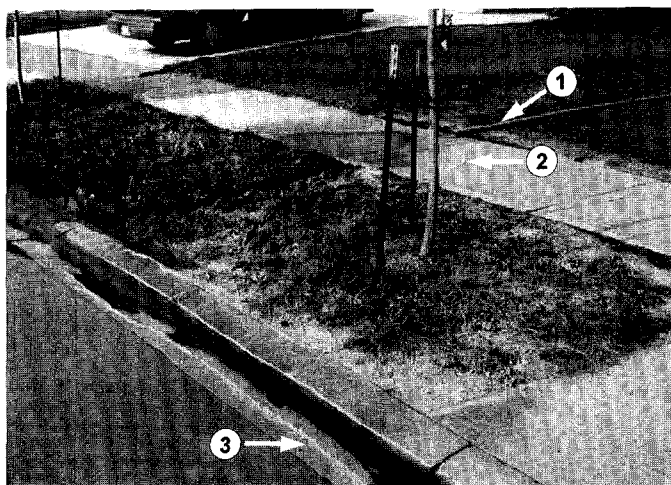
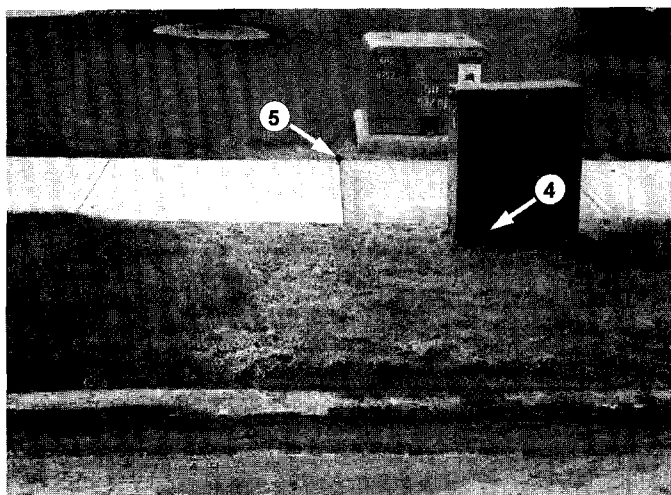
Figure 1. Positioning of sump pump effluent discharge hose at edge of sidewalk in proximity to boulevard. (A) New discharge hose (arrow 1) is visible prior to sod grass installation; salt residues (arrows 2 and 3) are evident on sidewalk and roadway after evaporation of effluent. (B) Damage caused by sump pump effluent seen as browning of boulevard grass and corrosion of a metal utility box (arrow 4) resulting from a hidden discharge hose (arrow 5).

Figure 1 shows the positioning of sump pump effluent-discharge hoses in proximity to boulevards, salt residues that were left behind after evaporation of effluent, and some of the damage to vegetation and a steel utility box caused by the effluent.

Sump pump activity at the Deer Ridge site was very high, and sump pump effluent collected from a local basement pump had an electrolytic conductivity of  $10.2 \text{ dS m}^{-1}$ . The high electrolytic conductivity of sump pump effluent suggests very high ion content, which likely contributed to the high levels of ions measured in soil from the Deer Ridge boulevards (Table 2). This might account for injury symptoms observed on boulevard ornamental trees (Figure 2A) and grass (Figure 1B) in the area.

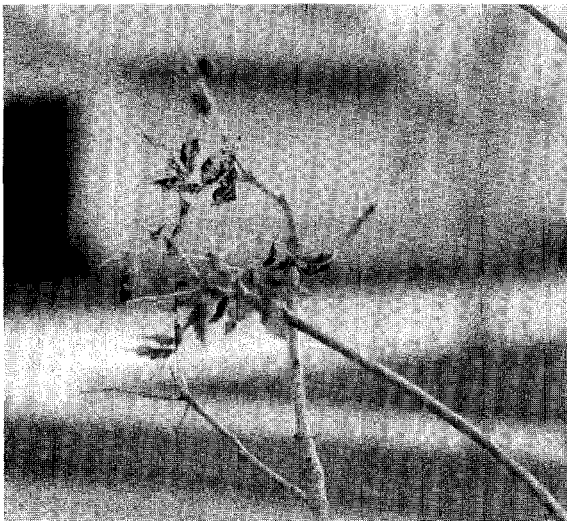
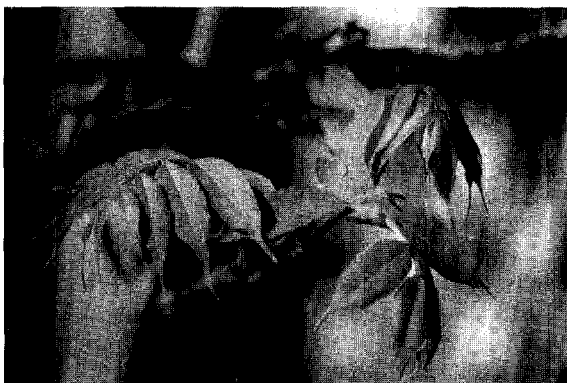
**Figure 2.** Appearance of late spring foliage on transplanted black ash trees at two different sites. (A) St. Albert-Deer Ridge, where sump pump effluent was discharged into boulevards. (B) Sherwood Park-Nottingham, where there was no sump pump effluent discharge.

stunted and showed signs of necrosis when compared to black ash trees located away from sump pump effluent discharge (Figure 2). New shoot die-back, leaf tip or leaf marginal browning, and many other injury symptoms exhibited by black ash trees located in proximity to sump pump effluent dis-

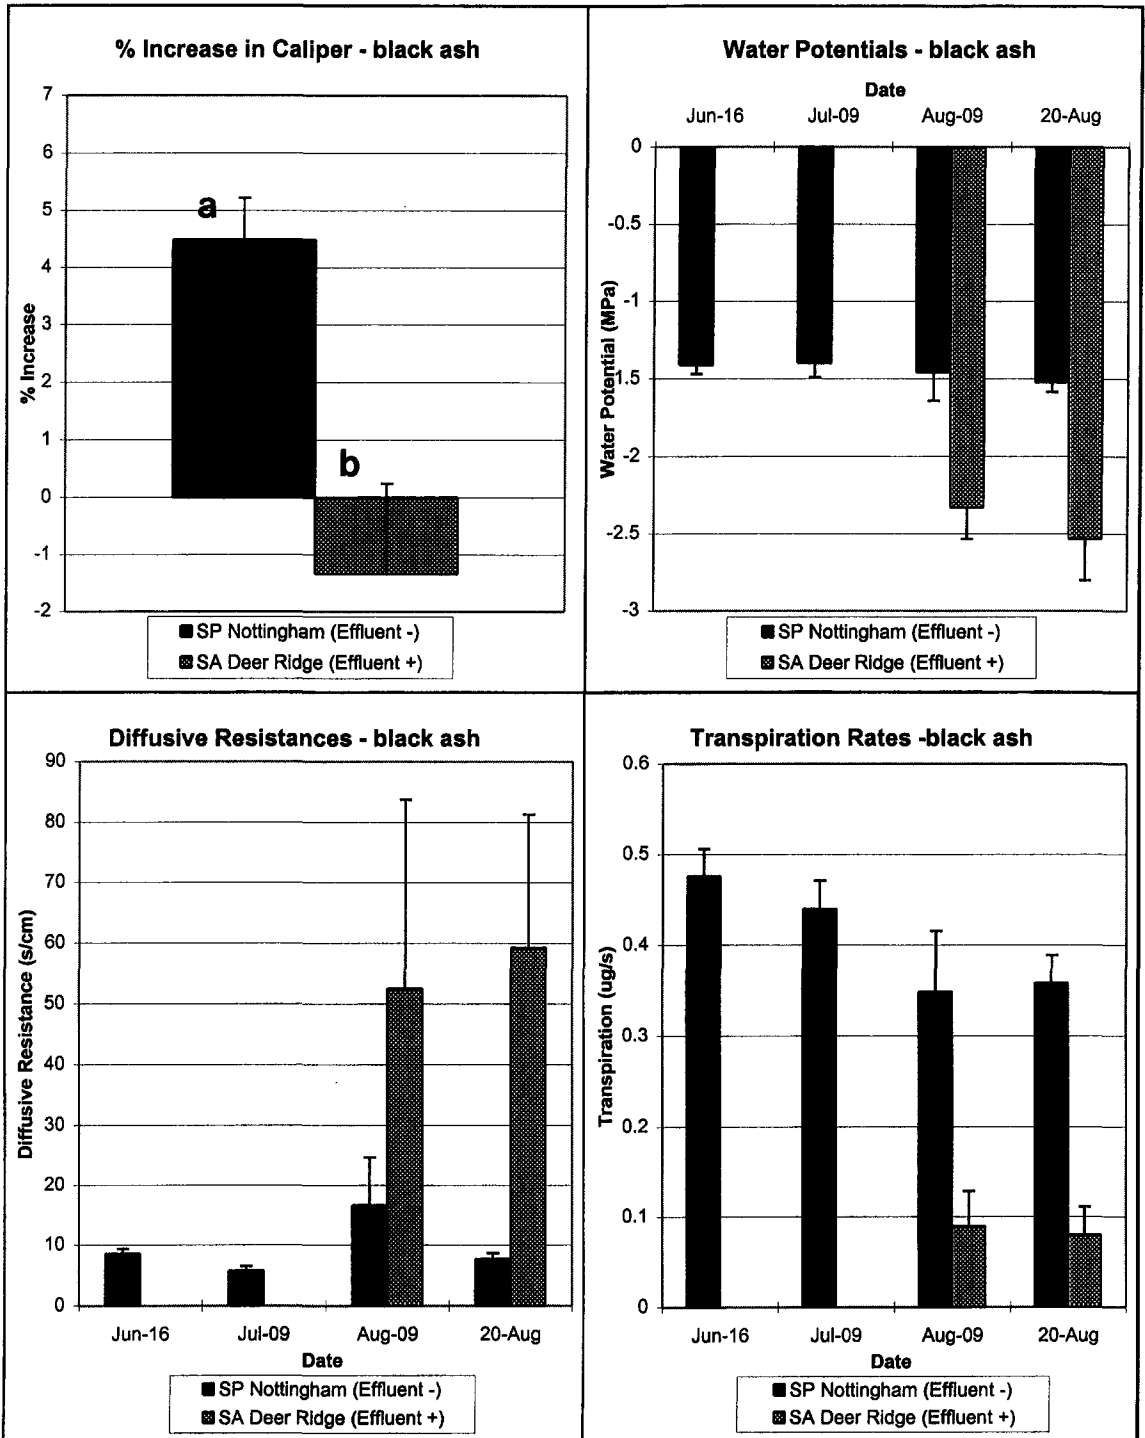
Figure 3. Caliper growth, leaf petiole water potentials, and gas exchange of black ash trees irrigated with sump pump effluent discharged into boulevards (effluent+), and black ash trees not irrigated with sump pump effluent (effluent-). Bars are means  $\pm$  standard error. Bars with the same letter are not significantly different.

UMA Planning & Design group measured representative soil electrolytic conductivity and major ion levels at several locations, near our study trees, in the Deer Ridge area (Table 2). Soil electrolytic conductivities and levels of sodium and sulfate varied widely but were among the highest at the St. Albert, Deer Ridge streets Donald Place and Delage Crescent. Both sites contained boulevard ornamental trees used in this study, and had abnormally high tree mortality rates where sump pump effluent was discharged directly into boulevards. At the Deer Ridge (Delage Crescent) site, 70% of the black ash study trees died before the end of the experiment, while the remaining 30% exhibited severely stunted growth and delayed spring bud flush. In black ash trees, altered water relations and significantly lower mean percent caliper increase (two-sample t-test significance level 0.01,  $P < 0.005$ ) were recorded at the St. Albert Deer Ridge site (effluent+) compared to trees at the Sherwood Park Nottingham site (effluent-) (Figure 3).

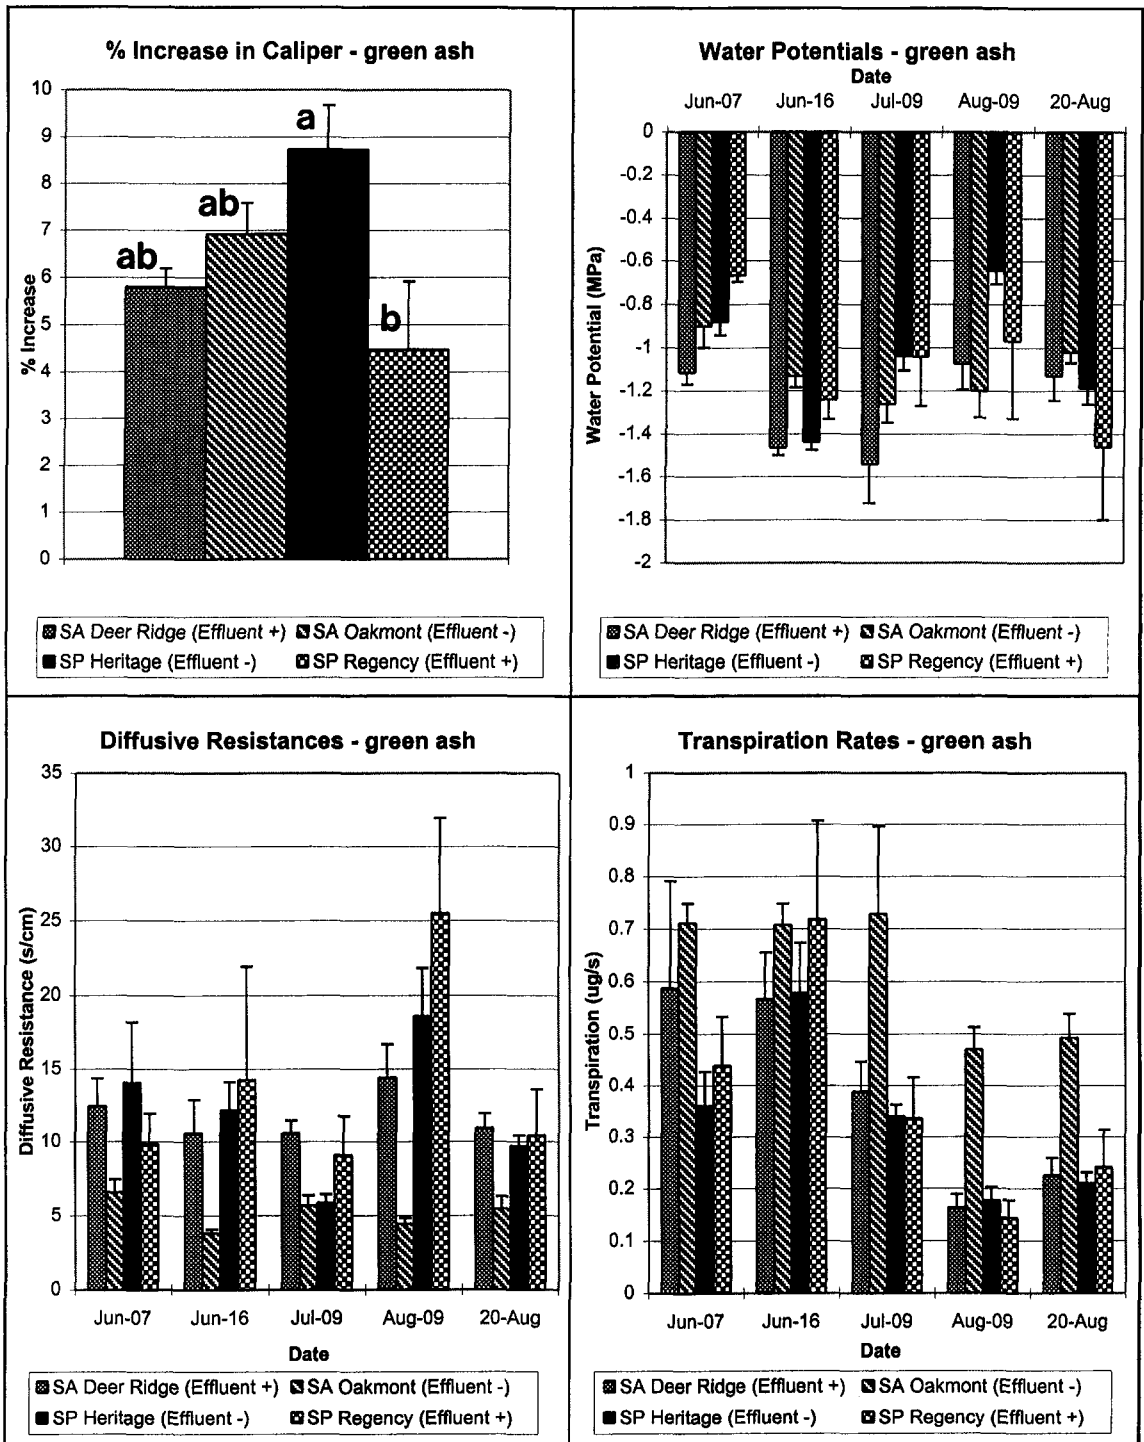
Figure 4. Caliper growth, leaf petiole water potentials, and gas exchange of green ash trees irrigated with sump pump effluent discharged into boulevards (effluent+), and green ash trees not irrigated with sump pump effluent (effluent-). Bars are means ± standard error. Bars with the same letter are not significantly different.

more than green ash trees at the Regency (effluent+) site. Green ash mean caliper percent increases at the two St. Albert sites (effluent+/-) were not significantly different. Green ash trees appeared to be more resistant to the negative effects of sump pump effluent discharge than black ash trees, as suggested by similar physiological responses between green ash trees subjected to irrigation with sump pump effluent and those that were not (Figure 4). However,
