## Research Note

# PRELIMINARY EVALUATION OF A LIVING WILLOW (*SALIX* SPP.) SOUND BARRIER ALONG A HIGHWAY IN QUÉBEC, CANADA

By Michel Labrecque and Traian Ion Teodorescu

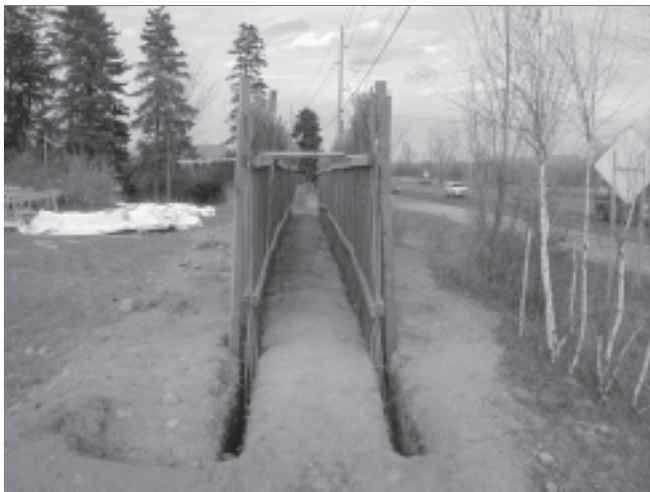
**Figure 2. Stems are assembled tightly in a wooden frame and installed upright in two trenches set 1.2 m (4 ft) apart.**

The construction was set up in April, as soon as the ground had thawed out. Following transport to the construction site, stems were quickly assembled tightly in the wooden frame and installed upright in two 1 m (3.3 ft) deep trenches set 1.2 m (4 ft) apart. The two willow walls were solidly held together by wood pieces and steel rods (Figures 1 and 2). A permeable, 2.5 m (8.2 ft) wide, thin geotextile was fastened inside over the entire length of the wall. The trenches were filled with a sandy-textured soil. A tractor equipped with a front loader was used to fill the space (with the same soil) between the two walls up to a height of 2.5 m (8.2 ft). At the end, a perforated irrigation hose connected to the municipal aqueduct was fixed at the base of the stems (20 cm [8 in.] above ground level) throughout the two sides of the wall. Once finished, the wall was 30 m (98 ft) long, 1.2 m (4 ft) wide, and 2.5 m (8.2 ft) high. More details about the construction of the wall are given in the patent description (Freitag 2001).

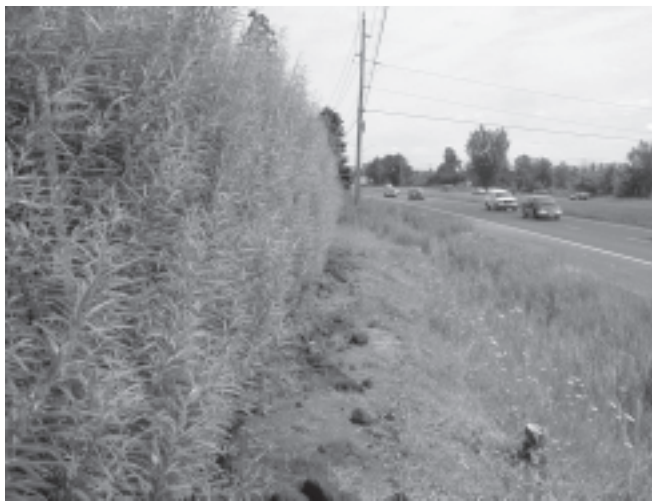
**Figure 3. About 8 weeks after establishment, the wall was completely green.**

Three weeks following the construction of the wall, opening buds and expanding shoots were observed at first on the south of the wall but, soon after, the stems on the north side also started to grow. About 8 weeks after establishment, the wall was completely green (Figure 3). Table 1 presents the characteristics measured on stems of each side of the wall at the end of the first growing season. The statistical analysis (ANOVA) of the data collected did not highlight any significant differences between the parameters measured on both sides of the wall. The average number of new branches developing on stems varied between 5.54 and 6.45, and they were almost equally distributed along the entire stem. At the end of summer, the newly developed branches reached almost 2 m (6.6 ft) in height, forming a wall 4.5 m (15 ft) high. The dry biomass of the newly developed branches was 2.17 kg (4.8 lb) and 1.93 kg (4.3 lb) per linear meter on the south and the north sides, respectively.
