# SOIL RESOURCE EVALUATION FOR A GROUP OF SIDEWALK STREET TREE PLANTERS

by Patrick Kelsey and Richard Hootman

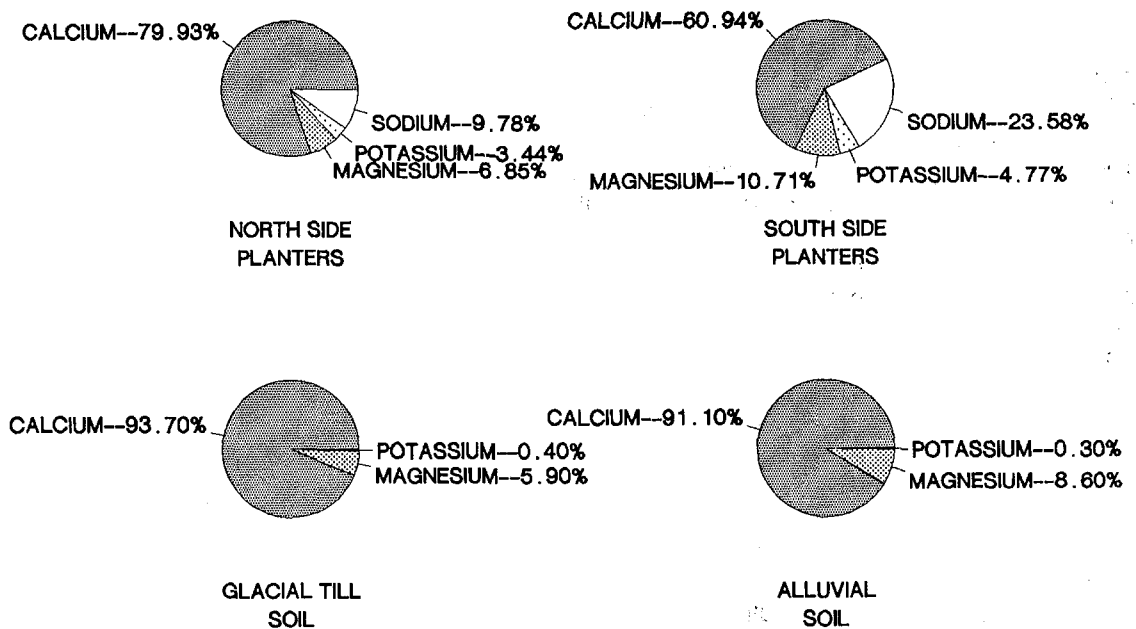
Data for planter soils from Geneva, Illinois.  
Data for natural soils from Lake Co., Illinois.

Figure 1. Mean base saturation levels in Geneva planter soils and native glacial till and alluvial soils.

Base saturation data for selected native soils of northeast Illinois and soils in the street tree planters of this study are provided in Figure 1 and highlight the severe chemical imbalances of these planter soils. Native soils have base saturations dominated by calcium while magnesium is a moderate percentage and potassium a small percentage (9). The Geneva planter soils had

base saturations dominated by calcium; however, sodium and potassium were very high, especially on the south side of the street.
