# WINDTHROW ALONG ELECTRICAL DISTRIBUTION LINES IN A RURAL SETTING

by Jean-Claude Ruel and Daniel Pin

**Abstract.** A blowdown survey was conducted along electrical distribution lines in a rural setting in order to identify the most important variables in estimating blowdown hazard. The variables usually involved in such an estimation did not prove very powerful in explaining blowdown density. In fact, blowdown was more related to the vegetation characteristics, namely size, species and vigour. This can be explained by an overriding effect of those characteristics in poorly managed stands that can be overmature and of low vigour. Specific studies are then needed to include those variables in blowdown hazard assessment.

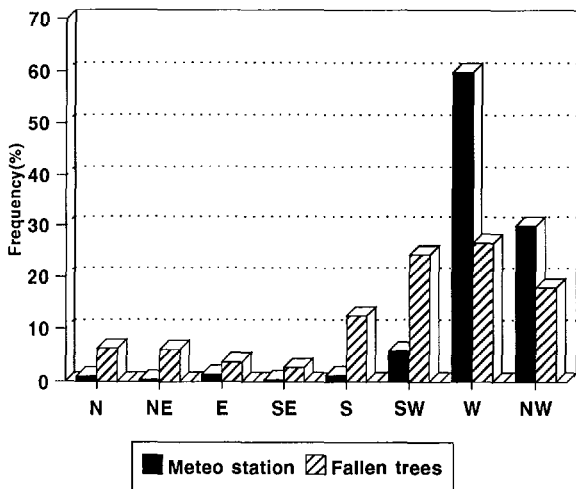
**Figure 2. Frequency directions of windspeeds over 40 km/h recorded at the nearest meteorological station and of actual winds that caused blowdown, as inferred from fallen trees.**

The analysis of the field survey reveals some similarities between the apparent direction of the damaging winds, as inferred from the direction of fallen trees, and the occurrence of strong winds recorded at the nearest meteorological station, located 25 km from the study area (Figure 2). Fall direction was generally in an eastern direction, indicating westerly damaging winds. This is in relative agreement with the occurrence of windspeeds over 40 km/h. This result would sug-

gest that meteorological station data could provide a rough estimate of the direction of potentially damaging winds over an area. However, significant differences ( $p < .005$ ) were observed between both frequency distributions. These differences are probably related to the effect of topography on wind behaviour (4).

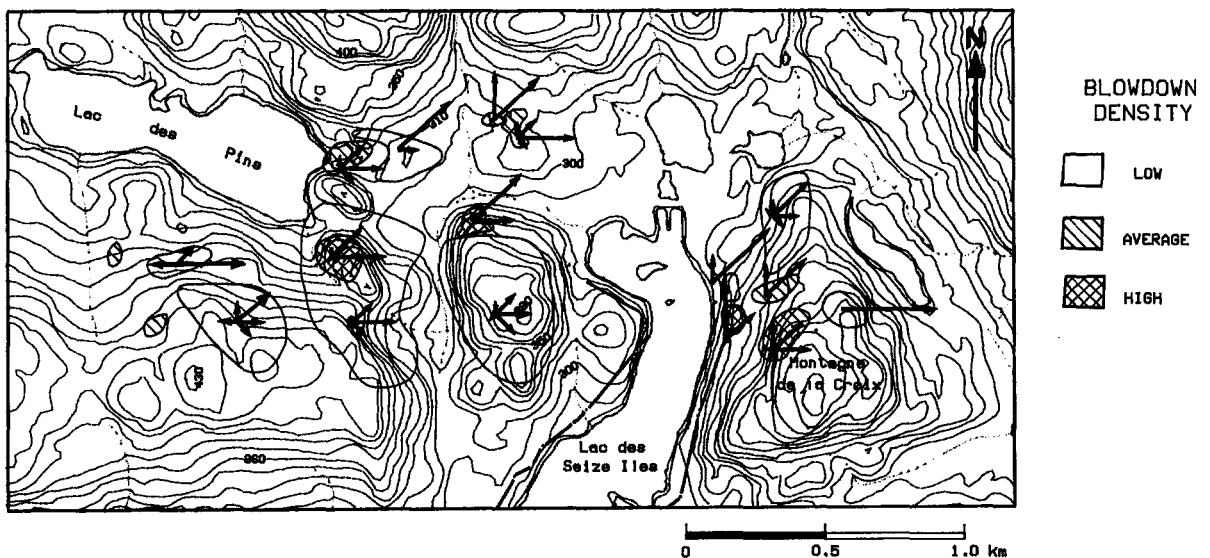
**Figure 3. Localization of blowdown from aerial photographs. Arrows are proportional to the frequency of treefall in each direction.**

on blowdown density was found. To further investigate the impact of topography on wind, it was necessary to resort to the aerial photographs. Figure 3 shows these results. A dominant easterly fall direction emerges, but with strong variations, this direction becoming northerly or north-easterly in the Lac-des-Seize-Iles area. Many high density zones were mapped, one such zone occurring east of Lac-des-Pins. This zone is associated with a funnelling effect at the end of the lake, further emphasized by the presence of a steep slope. It is well known that wind speed increases when flowing over an obstacle (4). On the western side of Lac-des-Seize-Iles, an intermediate concentration of blowdown (point A) can be seen where fall direction is northerly, parallel to the lake long axis. This agrees with the general observation that, in rugged topography, wind tends to follow the valleys (8). On top of Montagne-de-la-Croix, an area (point B) with no preferential fall direction is seen. This could correspond to an increase in turbulence behind an exposed crest (4). These results suggest that, even though potentially damaging wind direction can be roughly estimated by data from meteorological stations, reliable prediction at a local level would require a better understanding of the effect of topography on wind direction and strength.

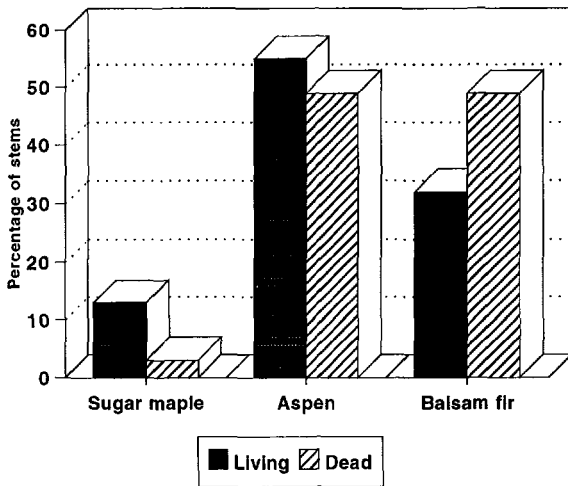
Figure 4. Species frequency in living and dead trees.

Four species accounted for 84% of the dead trees sampled. These were: balsam fir, aspen (bigtooth and quaking) and sugar maple. Other species were of relatively minor importance. The species frequency of dead trees differs significantly from that of living trees (Figure 4). Balsam fir comprised 49% of the total number of dead stems and 32% of the living stems. Sugar maple comprised 3% of the dead stems and 13% of the living stems. This seems to demonstrate a differential vulnerability of those species to windthrow. An effect of cover type was not seen in the preceding analysis of stand-level factors probably because many other factors also varied concurrently. We nevertheless can expect sugar maple stands to be less vulnerable and balsam fir stands to be more vulnerable. Sugar maple is generally believed to be a deeper rooting species and less prone to decay than balsam fir (5).

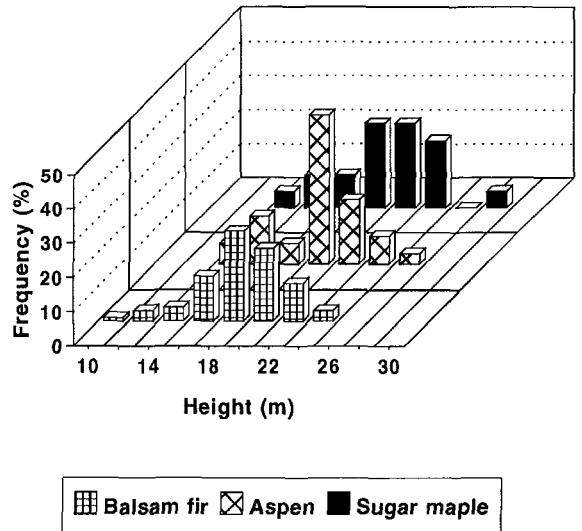
Figure 5. Height distribution by species in fallen trees.

Univariate statistics of fallen trees were compiled to characterize this population. In this case study, which should be viewed as a first step, the median was chosen to represent a certain critical height or diameter. Figure 5 shows the frequency distribution of height by species and Figure 6 displays the same information about diameter. Median values are presented in Table 1. Balsam fir becomes very affected by blowdown when it reaches 18 m while this occurs around 20 or 22 m for the other species. The height of fallen balsam fir and sugar maple trees is significantly greater than that of living trees (Table 2). This was not the case with aspen since some stands, with very tall trees, were found in sheltered situations. The results for the two former species indicate that stand height should be considered as a good indicator of windthrow hazard. The effect of tree diameter follows the same trend and the same conclusions can be drawn (Figure 6 and Table 2).

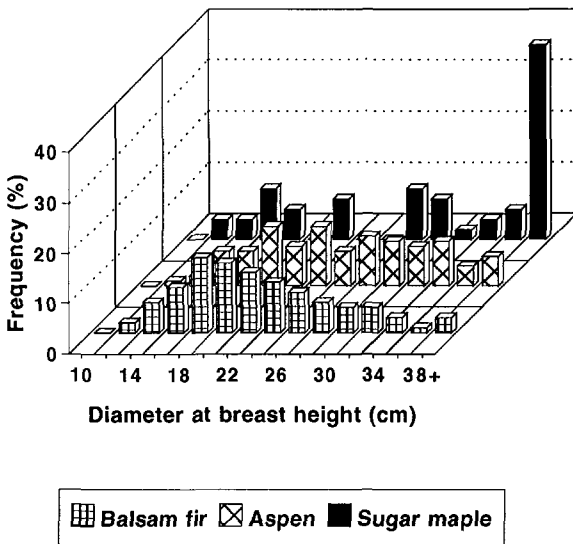
**Figure 6. Diameter distribution by species in fallen trees.**
