Roadside Vegetation Health Condition and Magnesium Chloride (MgCl₂) Dust Suppressant Use in Two Colorado, U.S. Counties

Betsy A. Goodrich, Ronda D. Koski, and William R. Jacobi

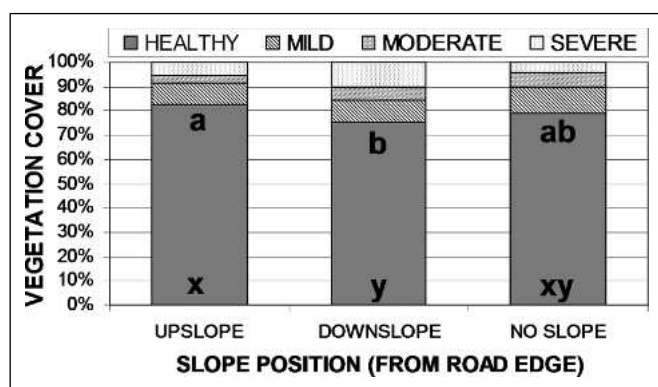
Figure 2. Roadside vegetation health condition adjusted means along nonpaved roads both treated and nontreated with $MgCl_2$ -based dust suppression products in Larimer and Grand Counties by slope position from road edge (healthy = less than 5% damage, mild = 5% to 25% damage, moderate = 26% to 50% damage, severe = greater than 50% damage to crown or stem; $n = 2,583$ plots including vegetation). Letters (a, b, ab) signify significant differences ($P < 0.05$) between percent of severely damaged vegetation among upslope, downslope, and no slope positions. Symbols (x, y, xy) signify significant differences ($P < 0.05$) between percent of healthy vegetation among upslope, downslope, and no slope positions.

The majority of roadside vegetation surveyed along nonpaved roads was considered healthy, depending on slope position from the road (72.3% to 79.3%). Proportions of severely damaged vegetation ranged in cover from 6.4% to 11.4% with the most severely damaged vegetation occurring downslope from the road (Figure 2). Although some proportion of severely damaged vegetation was observed at all slope positions from the road center, a larger percentage occurred downslope compared with upslope positions ($P < 0.0001$; Figure 2).

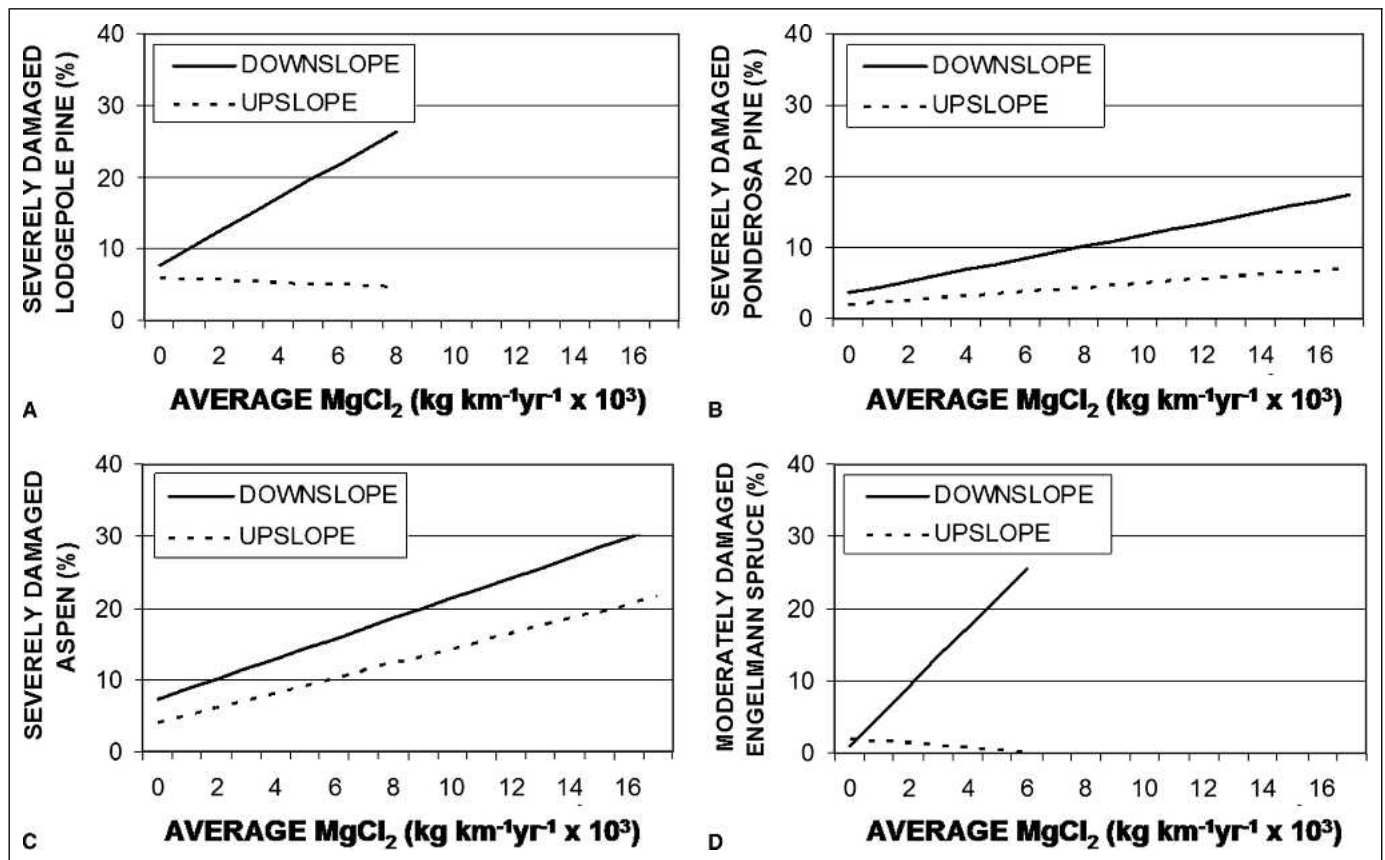
Figure 3. Modeled percent severely damaged lodgepole pine (A), ponderosa pine (B), and trembling aspen (C) and moderately damaged Engelmann spruce (D) adjusted means along nonpaved roads both treated and nontreated with MgCl₂-based dust suppression products in Larimer and Grand Counties by slope position and increasing amount of MgCl₂ applied per year (kg/km⁻¹/year⁻¹). The solution function in SAS 9.1 used to generate slopes for each species and slope position and only site factors that were significant at $P < 0.05$ are illustrated.

treated roads compared with nontreated roads (Table 3). Higher mean percentages of severely damaged lodgepole pine occurred downslope from the road (15.7%) compared with areas upslope from the road (7.3%), although no difference occurred between downslope trees and trees at no slope (14.9%). Overall, the percent of lodgepole pine with severe damage increased along nonpaved roads as the average amount of $MgCl_2$ applied increased (Figure 3A). The percentage of severely damaged trees downslope from the road increased with average application rate, whereas upslope trees did not (Figure 3A). The “no slope” position was not prevalent enough throughout the range of application rates to be included in this analysis of interaction and was dropped from all further interactions between slope and application rates.

Ponderosa pine was also common along roadsides and was a species component in 10.3% of the 2,583 plots, but only occurred along Larimer County roads. Ponderosa pine grew along a range of treated and nontreated roads, up to $16,600 kg/km^{-1}/yr^{-1}$ ($59,000 lb/mi^{-1}/yr^{-1}$). A higher percentage of severely damaged ponderosa pine was observed along treated roads compared with nontreated roads (Table 3). The percent of severely damaged trees increased at both slope positions with an increase in average application rate (Figure 3B). The average percent of ponderosa pine with severe damage was higher downslope from the road (5.3%) compared with upslope from the road (2.2%), although the rate of increase with application rates was equal between slope positions (Figure 3B).

along nontreated roads through roads treated with approximately 16,600 kg/km⁻¹/yr⁻¹ (59,000 lb/mi⁻¹/yr⁻¹). A higher percentage of severely damaged aspen was observed along treated roads compared with nontreated roads (Table 3). Downslope habitats had a higher proportion of severely damaged aspen trees (10.9%) than upslope (6.7%), and the percentage of severely damaged aspen increased with the average amount of MgCl₂ applied at similar rates both upslope and downslope from the road (Figure 3C).

Engelmann spruce occurred as a component of 99 plots along roads ranging from no MgCl₂ application to approximately 5,900 kg/km⁻¹/yr⁻¹ (21,000 lb/mi⁻¹/yr⁻¹). No significant differences occurred between the percent of severely damaged Engelmann spruce on treated versus nontreated roads, although a lower percentage of nondamaged (healthy) Engelmann spruce was observed along treated roads (Table 3). More moderately damaged (26% to 50% damage) spruce occurred along treated roads (15.9%) compared with nontreated roads (0.3%) and also occurred downslope (7.2%) compared with upslope from the road (1.8%) (Figure 3D). A positive relationship occurred between moderately damaged Engelmann spruce and average application rates ($P = 0.002$), and the percent cover of spruce with 26% to 50% damage increased with average application rate of MgCl₂ in downslope trees (Figure 3D).
