TREE ROOTS IN SEWER SYSTEMS IN MALMO, SWEDEN

by Kaj Rolf and Örjan Stål

Abstract. Three sites with root intrusion problems in the City of Malmö were inspected to find different solutions to the problems. All sites had high maintenance costs due to the roots. Alternative measures for each site were selected. Each site was treated differently depending on the technical, aesthetic, cultural and economical values. At one site, pipes were relined, at another the trees were replaced with less aggressive species and at the third a decision is yet to be made.

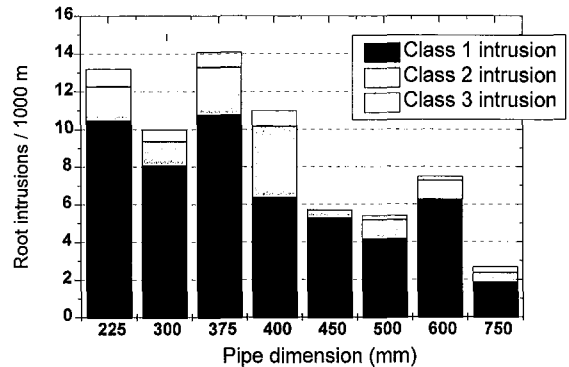
Root intrusion in sewer pipes has been well studied in the city of Malmö (1,2). The study is based on video recordings inside the pipes and provides data on root intrusions per 1000 m. Data are separated depending on age and dimension of the pipe. The most intrusions have been onto the smaller dimension pipes, 22.5 - 40 cm (Figure 1)(3), possibly because the larger dimensions are more often used as primary sewer lines or trunk sewers. These larger pipes are usually deeper in the soil and the roots may have problems growing down to them.

Figure 1. Root intrusion / 1000 m sewer pipe in the City of Malmö. Figures are divided into pipe dimensions.

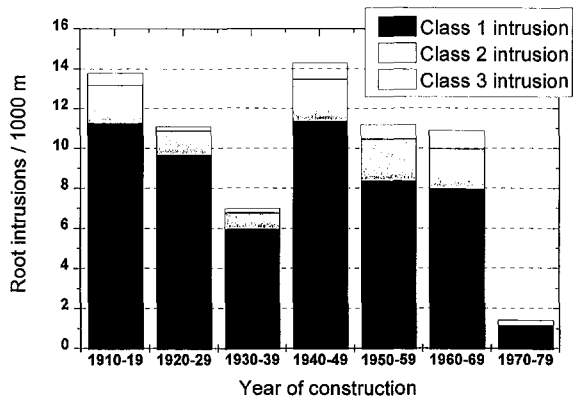
Data show that pipes laid down in the nineteen-fifties and earlier, with the exception of the nineteen-thirties, have the largest number of root intrusions (Figure 2)(1). During these years the sealing material was made of yarn and cement. During the war the quality of the material was poorer because of rationing. Why there were so few root intrusions in pipes from the nineteen-thirties is hard to explain. One reason may be that areas constructed during this period have not had so much vegetation near the pipes. During the nineteen-fifties the less effective plastic seals were introduced and from the nineteen-sixties to

Figure 2. Root intrusion / 1000 m sewer pipe in the City of Malmö. Figures are divided into year of construction.

now rubber seals have been used. The large number of root intrusions in pipes from the sixties may be explained by the boom in the construction industry. Construction work had to be fast and cheap, which created negligence during the work. There is also a hypothesis that the number of root intrusions in these pipes will increase when the trees get larger.

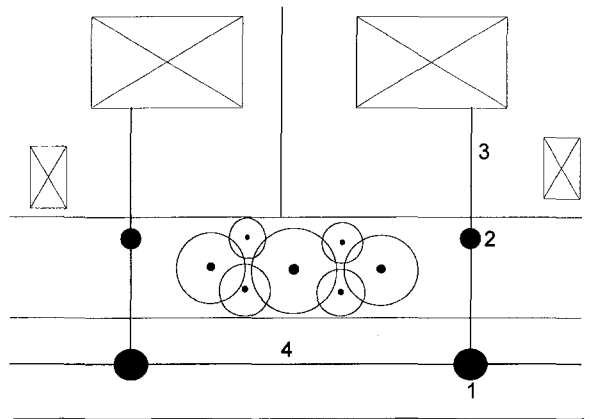
Figure 3. Trees are planted in groups to avoid planting near the service connections. The numerals represent :1. Manhole, 2. Inspection well, 3. Service connection, 4. Main sewer line.

Alternative 3, changed design. Instead of planting trees at specific distances from each other regardless of where the pipes are situated, this alternative points at a planting design that is influenced by the location of the pipes. Firstly, there is group planting (Figure 3) where trees are planted between the pipes, and secondly there is row planting (Figure 4) where different species are placed according to how aggressive the root system is. This places extra demands on the landscape architect to create a good design to use the right trees at the right places.

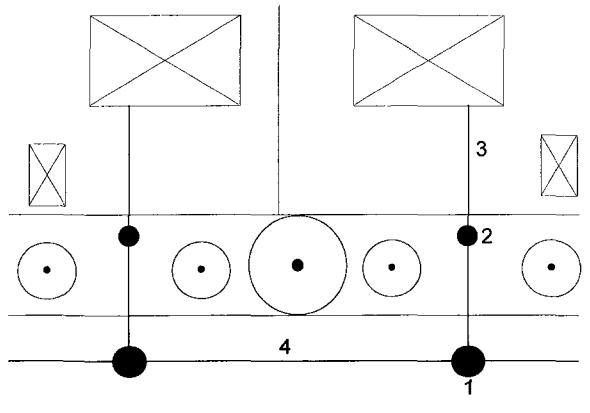
Figure 4. Trees are planted in a row but with non-aggressive species near the service connections. The numerals represent: 1. Manhole, 2. Inspection well, 3. Service connection, 4. Main sewer line.
