TREE-CAUSED ELECTRIC OUTAGES

by Peter Simpson and Rufin Van Bossuyt

Abstract. In 1995, Eastern Utilities was among 14 utilities in the United States and Canada participating in a study to collect and evaluate data about the phenomena of how trees cause outages. Results indicate that failure of trees accounted for 40% of the *preventable* tree-caused outages in the Brockton territory of Eastern Utilities. Even though line clearance tree trimming continues to be the primary strategy, *programmatically changes were made in Eastern Utilities' Tree Management Program.* A Danger Tree Project was initiated to identify and mitigate trees with structural weaknesses along the 3-phase portion of the electrical distribution circuits. Approximately 4% of the trees in the portion of the urban forest managed by Eastern Utilities will either be removed or storm-proof pruned. Reliability has improved by 20% to 30% along the circuits where hazardous trees have been removed or storm-proof pruning has been done. Proactive communication within the community and participation in community-based tree planting has accompanied this project.

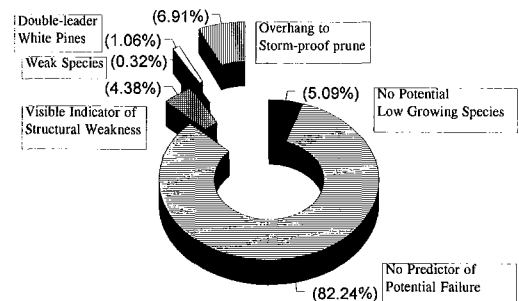
Figure 1. Categories of indicators of potential structural failure.

The percentages of these indicators of the potential for structural failure for the Brockton service territory is depicted in Figure 1.

Tree population survey. A survey of the tree population was conducted in the Brockton territory of the Eastern Utilities system. The territory consists of 17 communities and covers approximately 300 square miles. The objective of the survey was to locate trees with the characteristics that present the greatest risk from failure to the 3-phase portion of the distribution circuits. The survey was a simple random sample of 40% of the number of pole spans for the 3-phase portion of the primary electrical circuits. Random pole spans were selected on a map of primary circuits and the characteristics of the trees within those pole spans were categorized. The trees were categorized along the following 6 indicators of their potential to cause an outage from failure:

1. no predictor of potential failure
2. visible structural defect
3. overhanging limbs
4. weak species
5. white pines with co-dominant stems
6. no potential low growing species.
