TREE-CAUSED ELECTRIC OUTAGES

by Peter Simpson and Rufin Van Bossuyt

Abstract. In 1995, Eastern Utilities was among 14 utilities in the United States and Canada participating in a study to collect and evaluate data about the phenomena of how trees cause outages. Results indicate that failure of trees accounted for 40% of the *preventable* tree-caused outages in the Brockton territory of Eastern Utilities. Even though line clearance tree trimming continues to be the primary strategy, *programmatically changes were made in Eastern Utilities' Tree Management Program.* A Danger Tree Project was initiated to identify and mitigate trees with structural weaknesses along the 3-phase portion of the electrical distribution circuits. Approximately 4% of the trees in the portion of the urban forest managed by Eastern Utilities will either be removed or storm-proof pruned. Reliability has improved by 20% to 30% along the circuits where hazardous trees have been removed or storm-proof pruning has been done. Proactive communication within the community and participation in community-based tree planting has accompanied this project.

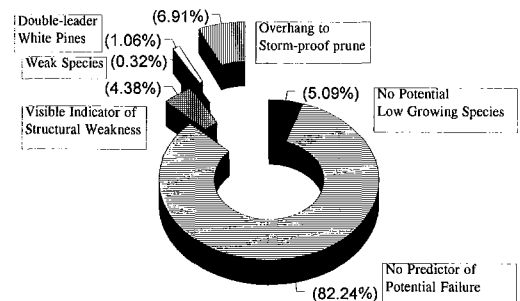
Figure 1. Categories of indicators of potential structural failure.

The percentages of these indicators of the potential for structural failure for the Brockton service territory is depicted in Figure 1.

Tree population survey. A survey of the tree population was conducted in the Brockton territory of the Eastern Utilities system. The territory consists of 17 communities and covers approximately 300 square miles. The objective of the survey was to locate trees with the characteristics that present the greatest risk from failure to the 3-phase portion of the distribution circuits. The survey was a simple random sample of 40% of the number of pole spans for the 3-phase portion of the primary electrical circuits. Random pole spans were selected on a map of primary circuits and the characteristics of the trees within those pole spans were categorized. The trees were categorized along the following 6 indicators of their potential to cause an outage from failure:

1. no predictor of potential failure
2. visible structural defect
3. overhanging limbs
4. weak species
5. white pines with co-dominant stems
6. no potential low growing species.

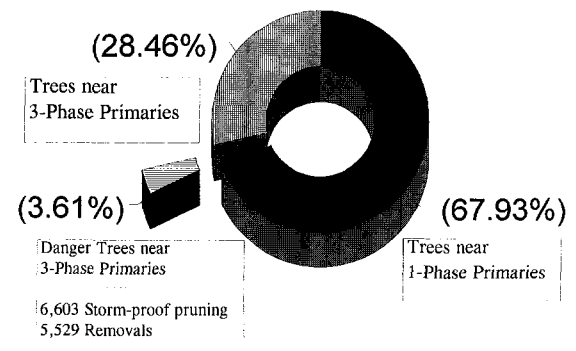
The distribution of the tree population in relation to the electrical network in the Brockton service territory is depicted in Figure 2. In summary, approximately 325,000 trees are trimmed to maintain clearance with electric lines. This excludes the service wires from a pole to a house. Approximately 30% (95,966) of the trees are adjacent to the 3-phase portion of electrical distribution circuits. Only 4% (12,159) of the trees are near the 3-phase portion of the primary circuits and had some indicator of structural weakness or did overhang the energized conductors. These trees with structural weaknesses adjacent to the 3-phase portion of the electrical circuits were those targeted for removal or storm-proof pruning in the Danger Tree Mitigation Project.

Figure 2. Distribution of tree population in relation to the portion of primary circuits in the Brockton service territory.
