TREE-CAUSED ELECTRIC OUTAGES

by Peter Simpson and Rufin Van Bossuyt

Abstract. In 1995, Eastern Utilities was among 14 utilities in the United States and Canada participating in a study to collect and evaluate data about the phenomena of how trees cause outages. Results indicate that failure of trees accounted for 40% of the *preventable* tree-caused outages in the Brockton territory of Eastern Utilities. Even though line clearance tree trimming continues to be the primary strategy, *programmatically changes were made in Eastern Utilities' Tree Management Program.* A Danger Tree Project was initiated to identify and mitigate trees with structural weaknesses along the 3-phase portion of the electrical distribution circuits. Approximately 4% of the trees in the portion of the urban forest managed by Eastern Utilities will either be removed or storm-proof pruned. Reliability has improved by 20% to 30% along the circuits where hazardous trees have been removed or storm-proof pruning has been done. Proactive communication within the community and participation in community-based tree planting has accompanied this project.

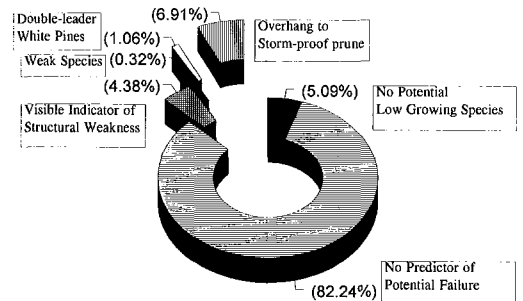
Figure 1. Categories of indicators of potential structural failure.

1. no predictor of potential failure
2. visible structural defect
3. overhanging limbs
4. weak species
5. white pines with co-dominant stems
6. no potential low growing species.

The percentages of these indicators of the potential for structural failure for the Brockton service territory is depicted in Figure 1.

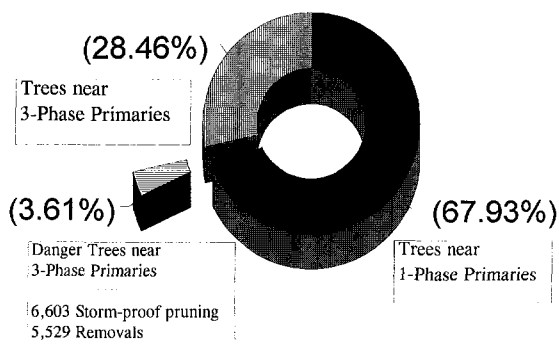
Figure 2. Distribution of tree population in relation to the portion of primary circuits in the Brockton service territory.

The distribution of the tree population in relation to the electrical network in the Brockton service territory is depicted in Figure 2. In summary, approximately 325,000 trees are trimmed to maintain clearance with electric lines. This excludes the service wires from a pole to a house. Approximately 30% (95,966) of the trees are adjacent to the 3-phase portion of electrical distribution circuits. Only 4% (12,159) of the trees are near the 3-phase portion of the primary circuits and had some indicator of structural weakness or did overhang the energized conductors. These trees with structural weaknesses adjacent to the 3-phase portion of the electrical circuits were those targeted for removal or storm-proof pruning in the Danger Tree Mitigation Project.
