# TREE-CAUSED ELECTRIC OUTAGES

by Peter Simpson and Rufin Van Bossuyt

**Abstract.** In 1995, Eastern Utilities was among 14 utilities in the United States and Canada participating in a study to collect and evaluate data about the phenomena of how trees cause outages. Results indicate that failure of trees accounted for 40% of the *preventable* tree-caused outages in the Brockton territory of Eastern Utilities. Even though line clearance tree trimming continues to be the primary strategy, *programmatically changes were made in Eastern Utilities' Tree Management Program.* A Danger Tree Project was initiated to identify and mitigate trees with structural weaknesses along the 3-phase portion of the electrical distribution circuits. Approximately 4% of the trees in the portion of the urban forest managed by Eastern Utilities will either be removed or storm-proof pruned. Reliability has improved by 20% to 30% along the circuits where hazardous trees have been removed or storm-proof pruning has been done. Proactive communication within the community and participation in community-based tree planting has accompanied this project.

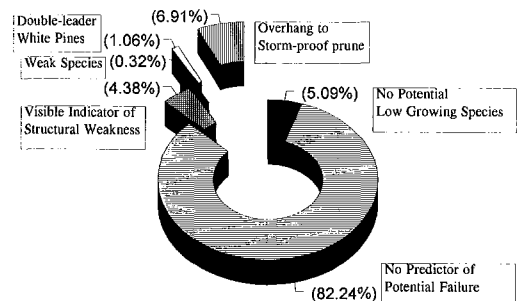
**Figure 1. Categories of indicators of potential structural failure.**

1. no predictor of potential failure
2. visible structural defect
3. overhanging limbs
4. weak species
5. white pines with co-dominant stems
6. no potential low growing species.

The percentages of these indicators of the potential for structural failure for the Brockton service territory is depicted in Figure 1.

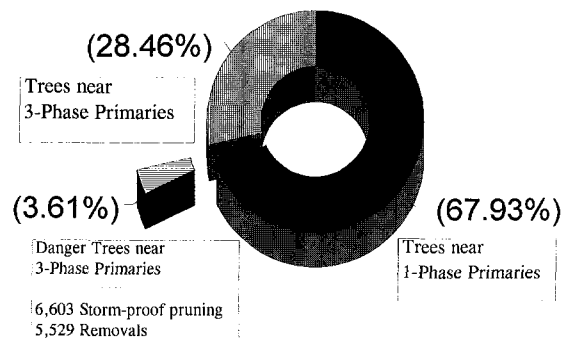
**Figure 2. Distribution of tree population in relation to the portion of primary circuits in the Brockton service territory.**

The distribution of the tree population in relation to the electrical network in the Brockton service territory is depicted in Figure 2. In summary, approximately 325,000 trees are trimmed to maintain clearance with electric lines. This excludes the service wires from a pole to a house. Approximately 30% (95,966) of the trees are adjacent to the 3-phase portion of electrical distribution circuits. Only 4% (12,159) of the trees are near the 3-phase portion of the primary circuits and had some indicator of structural weakness or did overhang the energized conductors. These trees with structural weaknesses adjacent to the 3-phase portion of the electrical circuits were those targeted for removal or storm-proof pruning in the Danger Tree Mitigation Project.
