STREET TREES IN HIGH-DENSITY URBAN HONG KONG

by C. Y. Jim

Abstract. High-density urban Hong Kong has a small population of street trees. A survey of 930 trees in two districts provide information on tree characteristics and for management. Of the 55 species encountered, few are numerically dominant and currently cultivated. The rare species are mainly woodland or garden relics. Species selection is shifting from native/large to introduced/small. Some popular species are not quite suitable for streets; a few rare voluntary species perform well. Most trees are concentrated along a few roads where growth space is available. Plantable space is a major bottleneck. The distribution of trees by growth type, position, and proximal landuse are discussed. Most trees have narrow crowns and are short-statured, suggesting a youthful population and/or a recent trend to plant small species. Two-thirds have arboricultural problems. Lack of tree data and of regular inspections make planning for tree care difficult. Maintenance is grossly inadequate due to lack of skilled workers. The poor tree health and defects are likely to persist.

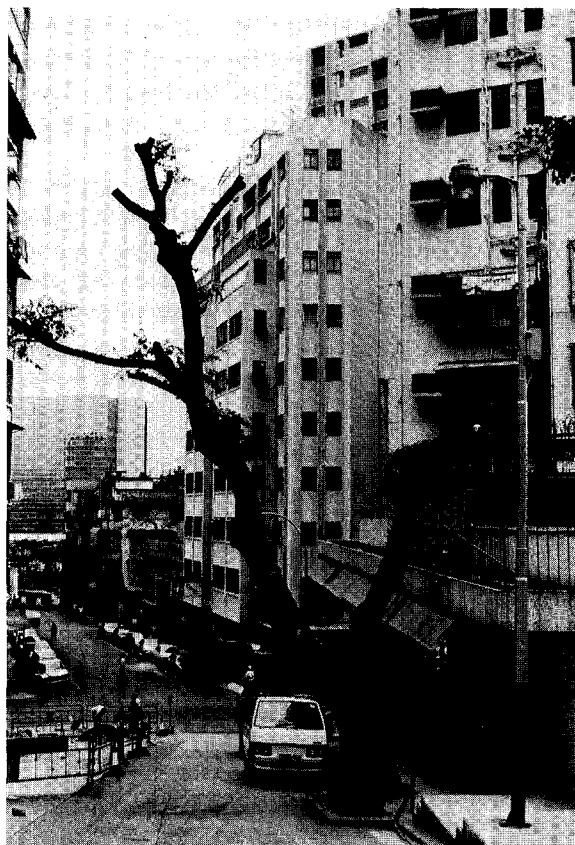
Fig. 1. This *Ficus microcarpa* (Chinese Banyan) had been lopped so excessively that the effort to keep it is rendered meaningless.

searching roots render it suitable for street planting only in ample roadside spaces. Many large specimens were sacrificed as the city expanded. Most of these trees have reached full size, and many show signs of decline. Some survivors are stranded incongruously in narrow streets, abutting adjacent buildings. Excessive pruning or lopping often were carried out to prevent obstruction to traffic or building redevelopment (Fig. 1). These maltreatments, plus senescence, leave few good trees of this species.

Physical restrictions. Above-ground space is very restricted for 7% of the trees. Physical obstacles include buildings (especially with awnings), vehicles, signs and lamp-posts (Fig. 1 and 5). The trees' crowns are incomplete. Wrong species, mis-siting, typhoon damage, construction, and general decline and dieback also cause this. Building or road development often has priority over trees' crowns (Fig. 1 and 5). Selection and siting cannot preclude landuse change.
