# STREET TREES IN HIGH-DENSITY URBAN HONG KONG

by C. Y. Jim

**Abstract.** High-density urban Hong Kong has a small population of street trees. A survey of 930 trees in two districts provide information on tree characteristics and for management. Of the 55 species encountered, few are numerically dominant and currently cultivated. The rare species are mainly woodland or garden relics. Species selection is shifting from native/large to introduced/small. Some popular species are not quite suitable for streets; a few rare voluntary species perform well. Most trees are concentrated along a few roads where growth space is available. Plantable space is a major bottleneck. The distribution of trees by growth type, position, and proximal landuse are discussed. Most trees have narrow crowns and are short-statured, suggesting a youthful population and/or a recent trend to plant small species. Two-thirds have arboricultural problems. Lack of tree data and of regular inspections make planning for tree care difficult. Maintenance is grossly inadequate due to lack of skilled workers. The poor tree health and defects are likely to persist.

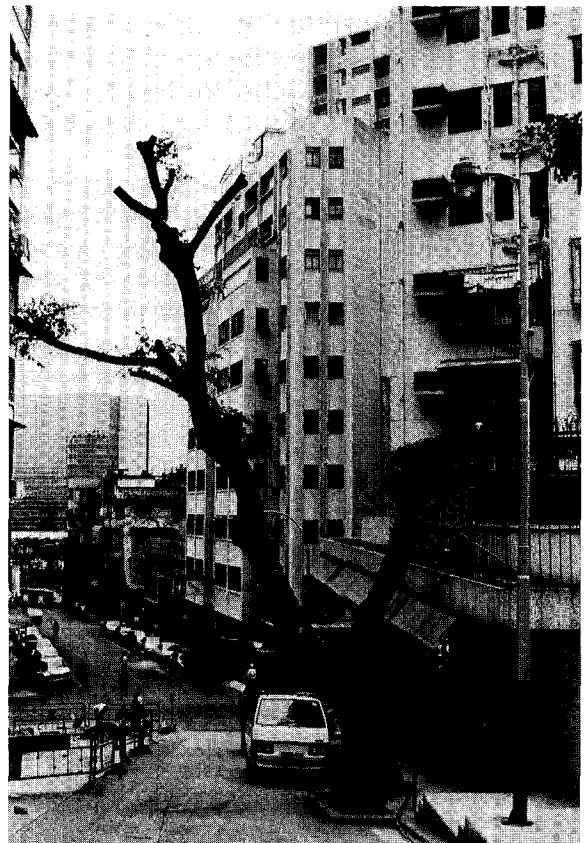
Fig. 1. This *Ficus microcarpa* (Chinese Banyan) had been lopped so excessively that the effort to keep it is rendered meaningless.

searching roots render it suitable for street planting only in ample roadside spaces. Many large specimens were sacrificed as the city expanded. Most of these trees have reached full size, and many show signs of decline. Some survivors are stranded incongruously in narrow streets, abutting adjacent buildings. Excessive pruning or lopping often were carried out to prevent obstruction to traffic or building redevelopment (Fig. 1). These maltreatments, plus senescence, leave few good trees of this species.

**Physical restrictions.** Above-ground space is very restricted for 7% of the trees. Physical obstacles include buildings (especially with awnings), vehicles, signs and lamp-posts (Fig. 1 and 5). The trees' crowns are incomplete. Wrong species, mis-siting, typhoon damage, construction, and general decline and dieback also cause this. Building or road development often has priority over trees' crowns (Fig. 1 and 5). Selection and siting cannot preclude landuse change.

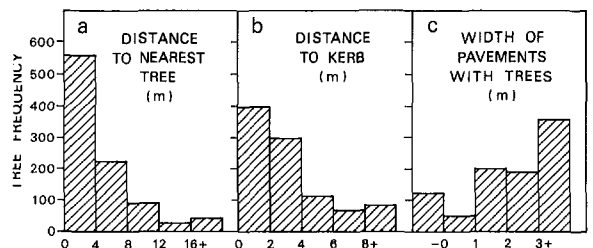
Fig. 2. The frequency of trees by the distance to the nearest tree, the distance to curb, and the width of pavements with trees.

Most pavements are too narrow (less than 2 m) for street planting. The common practice of building above them prevents planting in much of the city. Thus most of the trees are along a few of the roads. Of the street trees, 60% are separated from their nearest neighbour by less than 4 m, and 84% by less than 8 m (Fig. 2a). In all, less than 5% of the trees are solitary (no neighbour tree within 16 m). Most such isolated trees are mature or old, private garden relics or remnants. Because of narrow sidewalks, 75% of the trees are less than 4 m from the curb (Fig. 2b). With little on-street parking, fast moving vehicles, including double-decker buses, graze the tree crowns. Although most sidewalks with trees are wider than 2 m, 16% of the trees are found in sidewalks narrower than 1 m or where no sidewalk is present (Fig. 2c). The Highways Department normally does not allow planting where sidewalks are less than 2 m wide, for sake of road safety and pedestrian flow.

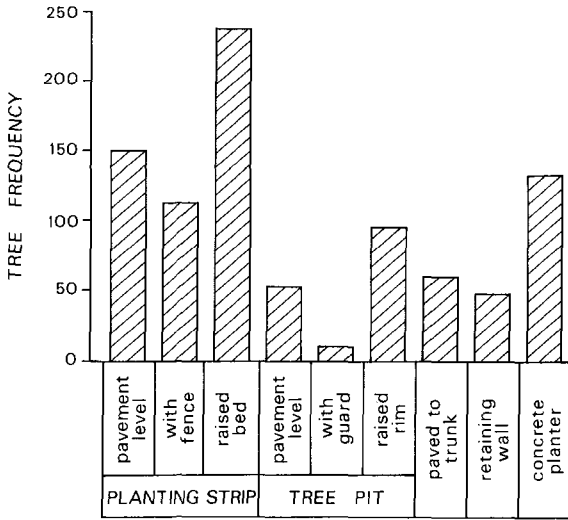
Fig. 3. The frequency of trees by nine types of growth space.

**Types of growth space.** Although nine types of street growth space are common in Hong Kong, about half of the trees are found in one of the three types of planting strips (Fig. 3). Most of these strips are narrower than 2 m but they are, by local standards, very generous. Most of these strips are along the few roads through low density areas, or new roads where space was reserved, by new planning standards, for amenity planting. Very few roads have more than one line of trees. About 16% of the trees are reared in pits, most of which are undersized and not equipped with grilles.
