# FACTORS AFFECTING ACCUMULATION OF DEICING SALTS IN SOILS AROUND TREES

by R.G. Hootman, P.D. Kelsey, R. Reid, and K. von der Heide-Spravka

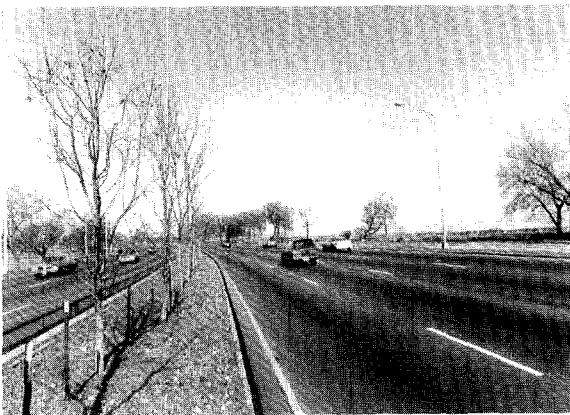
**Figure 1. Narrow median planter along Lake Shore Drive, Chicago, with Lake Michigan in the right background. The planter is raised 0.8 m (2.5 ft) above the roadway. Photo credit: Jim Nachel**

and two sites were within a wide, road-level median. Traffic counts at each site show essentially equal traffic levels (2). The narrow median is 3 m (10 ft) wide and raised 0.8 m (2.5 ft) above the roadway (Figure 1). The wide median is about 30 m (100 ft) across and level with the roadway. One surface soil sample (0-15 cm deep, 0-6 in) was gathered on 28 December 1992 and on 30 March 1993 in the center of each median site.

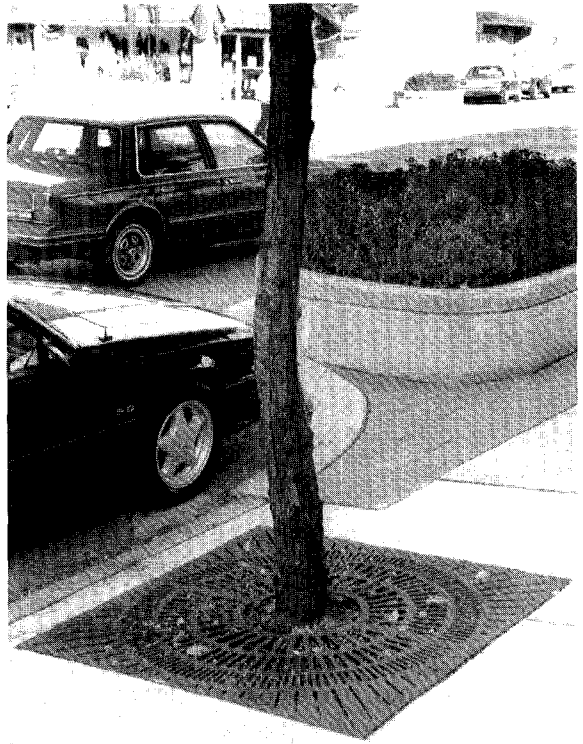
**Figure 2. Grade level and raised planters in Downers Grove. Photo credit: Jim Nachel**

Streets in the Downers Grove CBD are two lanes and speeds are less than 50 km per hour (30 mph) due to the stop-and-go traffic at intersections. A soil sample was taken at each of two grade level planters and each of two raised planters in 1991; only one grade level planter and one raised planter were sampled in 1993 (Figure 2). Samples in Downers Grove were taken at depths of 0-10 cm (0-4 in) and 20-30 cm (8-12 in).

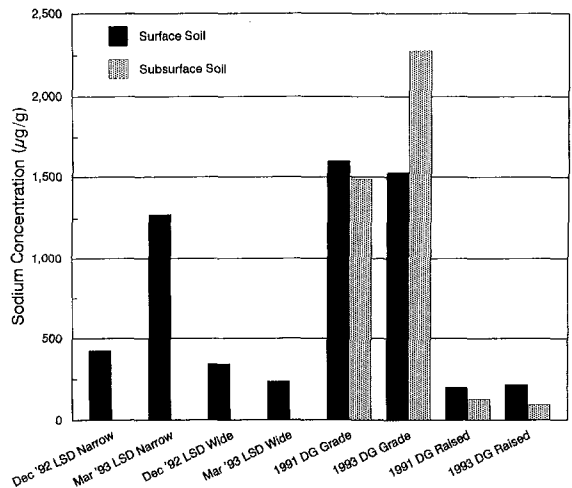
Figure 3. Mean soil sodium in Lake Shore Drive (LSD) and Downers Grove (DG) planters.

dium, chloride, SAR, and ESP between the beginning and end of the study (Table 1). Sodium and chloride increased to extremely high levels in the narrow median after only one season, although variation was quite high (Table 1 and Figure 3). Sodium saturation in this planter soil increased during the winter at the expense of calcium and magnesium saturation (Figure 4). Potassium showed little change. The close proximity of the narrow median to traffic and associated heavy splash and spray is the reason for the elevated levels. The high speed of the traffic was significant in causing the heavy splash and spray.
