FACTORS AFFECTING ACCUMULATION OF DEICING SALTS IN SOILS AROUND TREES

by R.G. Hootman, P.D. Kelsey, R. Reid, and K. von der Heide-Spravka

Abstract. Parkways, street tree planter boxes, and highway medians and roadsides are locations where soil accumulation of deicing salts is highest. Sodium chloride is the most common deicer applied in the United States. Sodium chloride and other salts accumulating in the root zone may instigate and exacerbate street tree decline. Salts affect soil aggregate stability, porosity, and water and nutrient uptake in trees. Data collected in Chicago, Illinois show much higher soil sodium (1,272 $\mu\text{g/g}$) and chloride (348 $\mu\text{g/g}$) in the center of newly installed, narrow, raised medians along Lake Shore Drive after one winter, compared to the center of wide medians along the roadway (236 $\mu\text{g/g}$ sodium and 23 $\mu\text{g/g}$ chloride). Proximity to high speed traffic and its associated spray and splash were reasons for this. In suburban Downers Grove, Illinois, grade level street tree planter soils had extremely high levels of sodium (1,426 $\mu\text{g/g}$ to 2,277 $\mu\text{g/g}$) compared to adjacent raised planter soils. The

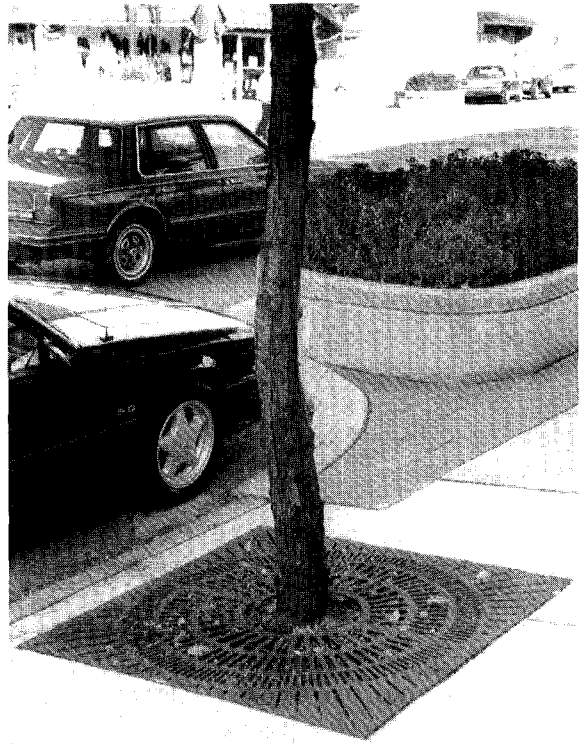
Figure 2. Grade level and raised planters in Downers Grove. Photo credit: Jim Nachel

Streets in the Downers Grove CBD are two lanes and speeds are less than 50 km per hour (30 mph) due to the stop-and-go traffic at intersections. A soil sample was taken at each of two grade level planters and each of two raised planters in 1991; only one grade level planter and one raised planter were sampled in 1993 (Figure 2). Samples in Downers Grove were taken at depths of 0-10 cm (0-4 in) and 20-30 cm (8-12 in).

Despite being located adjacent to the street, the raised planters have significant advantages with regard to salt protection. Unlike Lake Shore Drive, traffic splash is minimal here because of the lower traffic speed. Sidewalk meltwater cannot run off into these planters. The data reflect these observations. Sodium, chloride, SAR, and ESP were very low and do not represent a stressful plant environment (Table 1 and Figure 3). Changes from 1991 to 1993 were negligible, suggesting sodium and chloride deposition was minimal during that time.
