EFFECTS OF ROAD DISTANCE AND PROTECTIVE MEASURES ON DEICING NaCl DEPOSITION AND SOIL SOLUTION CHEMISTRY IN PLANTED MEDIAN STRIPS

by Lars Bo Pedersen¹, Thomas B. Randrup², and Morten Ingerslev³

Abstract. The deposition pattern of deicing salt and the resulting concentrations in the soil water were determined in planted median strips of two major approach roads with speed restrictions of 70 kmh (43.5 mph) in Copenhagen, Denmark. The objectives were to evaluate the effect of distance from the roadside and to test different straw mat protective measures. Deposition and soil water concentrations of sodium chloride (NaCl) decreased significantly within 2 m (6.6 ft) from the roadside compared to areas farther away. Straw mats mounted like a skirt around the tree stem did not constitute a proper protection against salt spray or splash and high salt concentrations in the soil water. In contrast, protection with straw mats on all sides of the trees resulted in a small but measurable effect. The highest concentrations of NaCl in the soil water were seen during the winter. However, there was a strong tendency of elevated concentrations persisting throughout the subsequent summer, which sugge

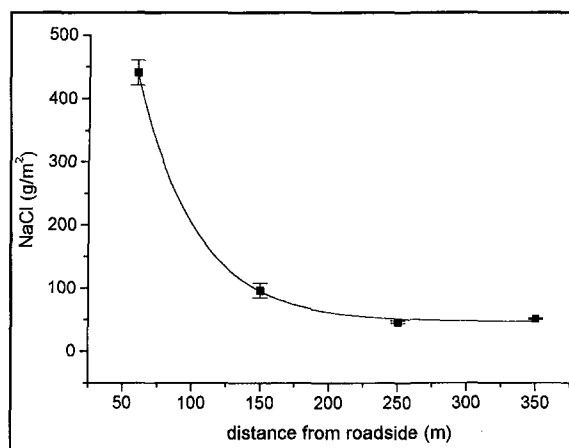
Figure 2. Deposition of road salt (NaCl) at different roadside distances at the median strip at RV. Error bars are calculated as standard errors ($n = 3$). The presented curve is the best first-order exponential fit.

The salt deposition in the two years was comparable in magnitude, although the distribution varied with the largest amount deposited in February 1997 and 1998 and in March 1998 and 1999. Figure 2 illustrates the average yearly deposition at RV at different roadside distances. The mean deposition in the two years was $441 \text{ g}/\text{m}^2$ at 0.6 m (2 ft), $96 \text{ g}/\text{m}^2$ at 1.5 m (5 ft), $46 \text{ g}/\text{m}^2$ at 2.5 m (8.2 ft), and $51 \text{ g}/\text{m}^2$ at 3.5 m (11.5 ft). Beyond 2 m (6.6 ft), no significant change in the salt load could be observed. The slightly larger deposition at 3.5 m compared to that at 2.5 m could probably be explained by additional deposition from the opposite roadside (distance approximately 2.5 m). The largest deposition definitely occurred close to the roadside and seemed to decline exponentially toward the middle of the median strip.

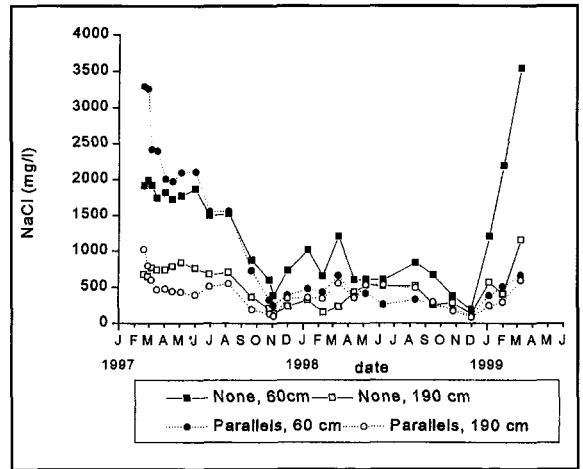
Figure 3. Concentration of NaCl in the soil water at the median strip at KV. Concentraions are given for distances of 60 an 190 cm (24 and 75 in.) from the roadside without protective measures as well as with a protection measure of parallel straw mats.

During the study period, soil water salt concentrations were high, between 20 and 100 times as high as under forest conditions in Denmark (Pedersen 1993; Pedersen and Bille-Hansen 1995). Even though the concentrations peaked in the salt application period during winter dormancy (Figure 3 and Figure 4), the concentrations remained high during the period of growth (Table 3). Despite abundant precipitation (200 to 300 mm [7.9 to 11.8 in.]), there was a tendency to only insignificantly decrease concentrations during spring followed by increasing concentrations during the summer and a pronounced decrease in the late autumn.

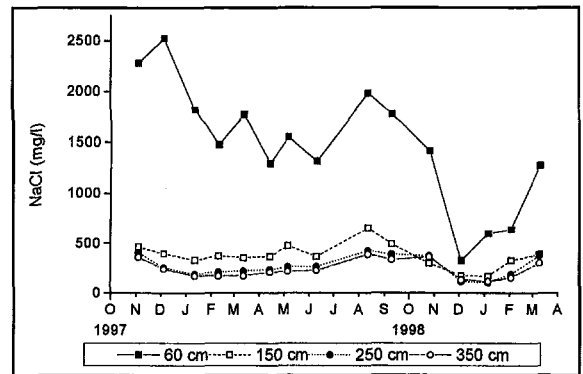
Figure 4. Concentration of NaCl in the soil water at different distances at RV (without protective measures).

NaCl concentrations in the soil water mirrored the deposition figures. Very high concentrations occurred close to roadside. The average NaCl concentrations for the whole study period were 1,595 mg/L at 0.6 m (2 ft), 384 mg/L at 1.5 m (5 ft), 248 mg/L at 2.5 m (8.2 ft), and 235 mg/L at 3.5 m (11.5 ft) from the roadside. As with deposition, the soil water concentrations seemed to decline exponentially toward the middle of the median strip, with only insignificant changes beyond 2 m (6.6 ft).
