EFFECTS OF ROAD DISTANCE AND PROTECTIVE MEASURES ON DEICING NaCl DEPOSITION AND SOIL SOLUTION CHEMISTRY IN PLANTED MEDIAN STRIPS

by Lars Bo Pedersen¹, Thomas B. Randrup², and Morten Ingerslev³

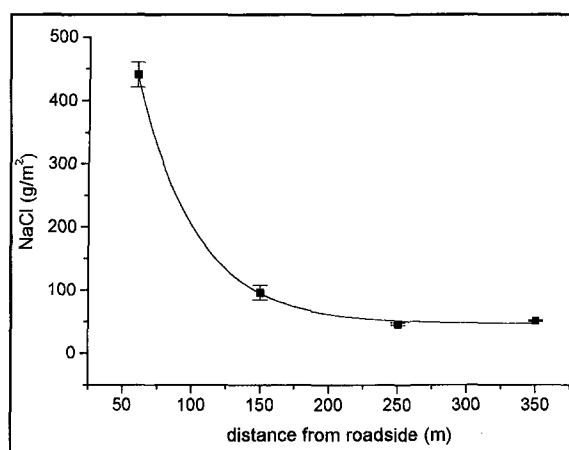
Figure 2. Deposition of road salt (NaCl) at different roadside distances at the median strip at RV. Error bars are calculated as standard errors ($n = 3$). The presented curve is the best first-order exponential fit.

The salt deposition in the two years was comparable in magnitude, although the distribution varied with the largest amount deposited in February 1997 and 1998 and in March 1998 and 1999. Figure 2 illustrates the average yearly deposition at RV at different roadside distances. The mean deposition in the two years was 441 g/m^2 at 0.6 m (2 ft), 96 g/m^2 at 1.5 m (5 ft), 46 g/m^2 at 2.5 m (8.2 ft), and 51 g/m^2 at 3.5 m (11.5 ft). Beyond 2 m (6.6 ft), no significant change in the salt load could be observed. The slightly larger deposition at 3.5 m compared to that at 2.5 m could probably be explained by additional deposition from the opposite roadside (distance approximately 2.5 m). The largest deposition definitely occurred close to the roadside and seemed to decline exponentially toward the middle of the median strip.
