DEFENDING STREET TREES AGAINST ROAD SALT IN DENMARK¹

by Niels Hvass

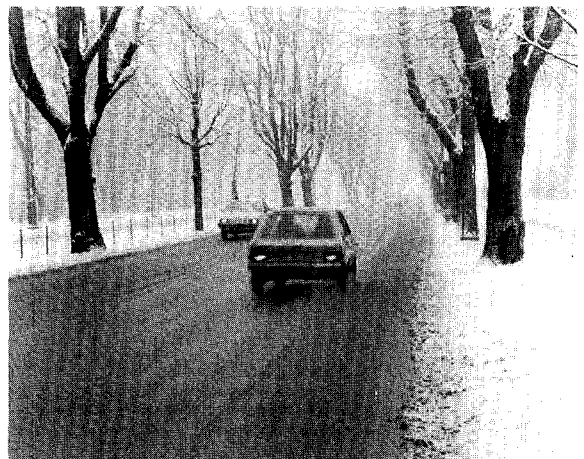
Fig. 1. Winter situation in Denmark. It is seldom chaotic because of heavy snowfall. However, the fast changes between thaw and frost, rain and snow make it difficult to control the road against ice slipperiness.

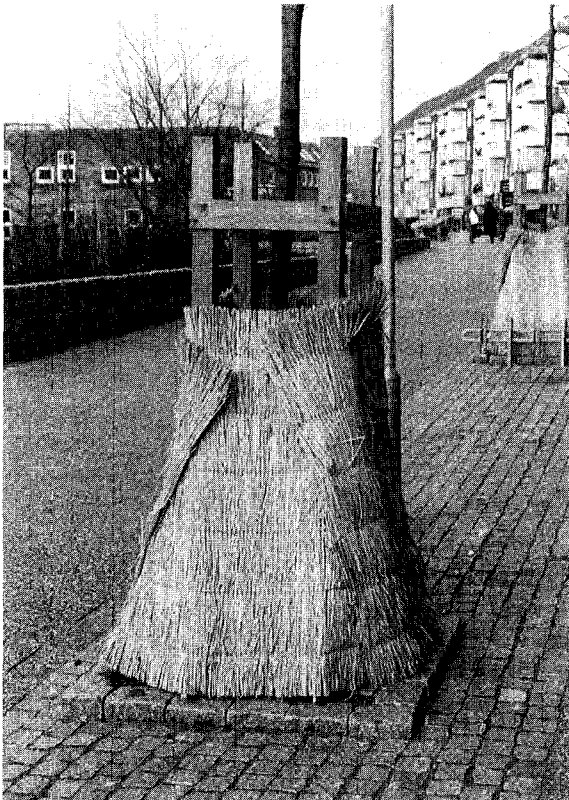
Fig. 6. A slightly elevated planting area. Nearly all the salt water is led to the drain.

There are many ways of improving the conditions for street trees. Most important is planting them at an elevated level so that the poisoned surface water runs away from the planting site. Heightened plant beds (20-40 cm) with waterproof sides towards the road and sidewalk are recommended. It is even better if the trunks of the trees are protected with straw mats during the winter. These straw mats are today well accepted by the public aesthetically, even though many of them look rather "weary" at the end of the winter.
