# EFFECTS OF ROAD DISTANCE AND PROTECTIVE MEASURES ON DEICING NaCl DEPOSITION AND SOIL SOLUTION CHEMISTRY IN PLANTED MEDIAN STRIPS

by Lars Bo Pedersen<sup>1</sup>, Thomas B. Randrup<sup>2</sup>, and Morten Ingerslev<sup>3</sup>

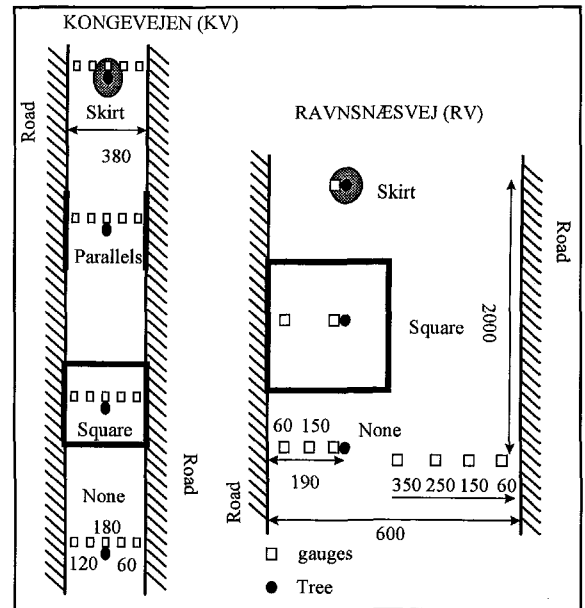
Figure 1. Experimental area at the median strips at Ravnsnæsvej (RV) and Kongevejen (KV), Copenhagen, Denmark. At RV, only one of the tree groups is shown.

At RV, three groups of trees were included. Two types of straw mat configurations were tested against a control without protection. One protective measure was a box or square around the tree. The dimensions of the square were approximately 3 × 3 m (10 × 10 ft). The other protective measure was a skirt around the tree trunk. The height of the skirt was 1.2 m (4 ft). At the soil surface, the diameter of the skirt was approximately 1.0 m (3.3 ft). At the top, the skirt was wound tightly around the trunk, but stem flow was not prevented.

The trees at KV were generally unhealthy, suffering from premature autumn coloring and twig and limb dieback, and most trees showed a characteristic witch's broom structure. At this site, three types of straw mat configurations were compared to a control (Figure 1). Besides the box or square and the skirt protective measures, an arrangement of parallel straw mats (parallels) was included. Except for the mats transversing the strip (connecting the mats run-

ning parallel along the roadsides), this setup was identical to that of the square. All sides of the square as well as of the parallel were 3.8 m (12.5 ft) long. The skirt had the same dimensions as on RV.

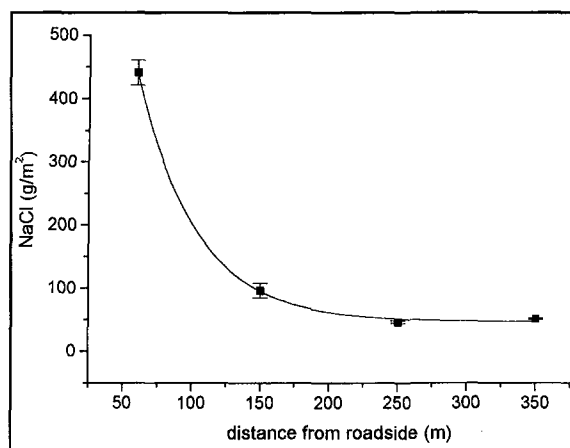
**Figure 2. Deposition of road salt (NaCl) at different roadside distances at the median strip at RV. Error bars are calculated as standard errors ( $n = 3$ ). The presented curve is the best first-order exponential fit.**

The salt deposition in the two years was comparable in magnitude, although the distribution varied with the largest amount deposited in February 1997 and 1998 and in March 1998 and 1999. Figure 2 illustrates the average yearly deposition at RV at different roadside distances. The mean deposition in the two years was  $441 \text{ g/m}^2$  at 0.6 m (2 ft),  $96 \text{ g/m}^2$  at 1.5 m (5 ft),  $46 \text{ g/m}^2$  at 2.5 m (8.2 ft), and  $51 \text{ g/m}^2$  at 3.5 m (11.5 ft). Beyond 2 m (6.6 ft), no significant change in the salt load could be observed. The slightly larger deposition at 3.5 m compared to that at 2.5 m could probably be explained by additional deposition from the opposite roadside (distance approximately 2.5 m). The largest deposition definitely occurred close to the roadside and seemed to decline exponentially toward the middle of the median strip.

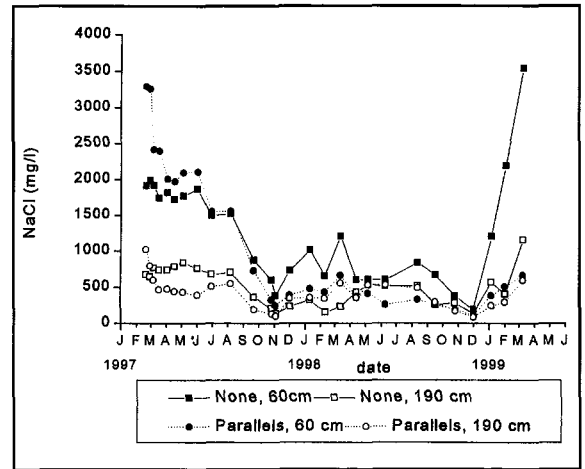
Figure 3. Concentration of NaCl in the soil water at the median strip at KV. Concentraions are given for distances of 60 an 190 cm (24 and 75 in.) from the roadside without protective measures as well as with a protection measure of parallel straw mats.

During the study period, soil water salt concentrations were high, between 20 and 100 times as high as under forest conditions in Denmark (Pedersen 1993; Pedersen and Bille-Hansen 1995). Even though the concentrations peaked in the salt application period during winter dormancy (Figure 3 and Figure 4), the concentrations remained high during the period of growth (Table 3). Despite abundant precipitation (200 to 300 mm [7.9 to 11.8 in.]), there was a tendency to only insignificantly decrease concentrations during spring followed by increasing concentrations during the summer and a pronounced decrease in the late autumn.

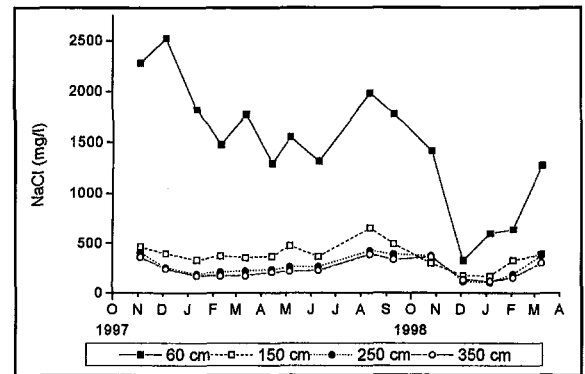
Figure 4. Concentration of NaCl in the soil water at different distances at RV (without protective measures).

NaCl concentrations in the soil water mirrored the deposition figures. Very high concentrations occurred close to roadside. The average NaCl concentrations for the whole study period were 1,595 mg/L at 0.6 m (2 ft), 384 mg/L at 1.5 m (5 ft), 248 mg/L at 2.5 m (8.2 ft), and 235 mg/L at 3.5 m (11.5 ft) from the roadside. As with deposition, the soil water concentrations seemed to decline exponentially toward the middle of the median strip, with only insignificant changes beyond 2 m (6.6 ft).
